NATIONAL RADIO ASTRONOMY OBSERVATORY
Socorro, New Mexico

VLBA Antenna Memo Series No. 48

St. Croix Elevation Bearing Replacement - Trip Report

J. E. Thunborg
September 10, 2003

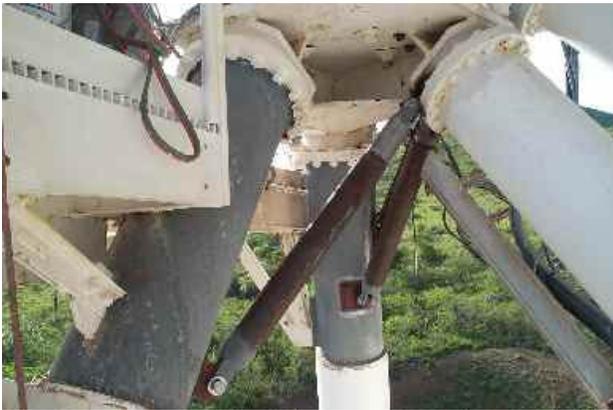
Metal particles were found in the grease on the condenser side elevation bearing at St Croix. After carefully watching this bearing for several months, it was decided that the bearing needed to be replaced. Steve Aragon, Kelly Greene, Ramon Gutierrez, Phillip Sanchez and Jon Thunborg were dispatched to St Croix to replace the bearing with the capable help of site technicians Peter Allen and Tazewell Reed.

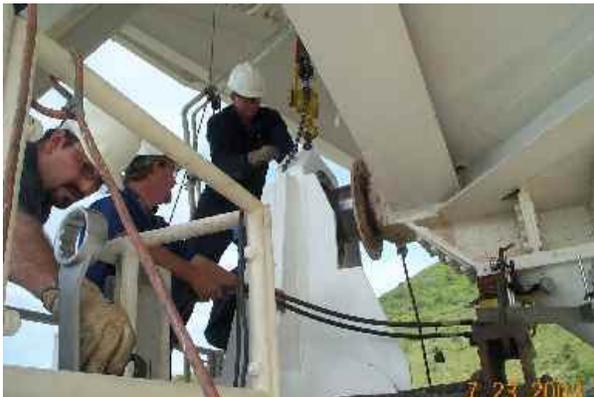
During the Las Alamos elevation bearing change, we experienced deflections in the antenna structure that were greater than were desired. Therefore, the finite element model was refined to better simulate the entire structure under the load path required for the bearing change. Using this model, it was found that installing the two struts shown in the photo in addition to the jack support beam, brace beam and anti-rotation pin that were installed in Las Alamos as described in

VLBA antenna memo #29 significantly reduced both the stress and deflection of the structure.
