National Radio Astronomy Observatory
Socorro, New Mexico
VLBA Antenna Memo #69

Fort Davis, Texas VLBA Maintenance Visit May 01-08, 2007.
Team members consisted of Steve Aragon, Eric Carlowe, Ken Lakies,
Ray McFarlin, and Phillip Sanchez. VLBA Site Technicians John Smith
and John Jordon assisted in all areas of antenna maintenance.

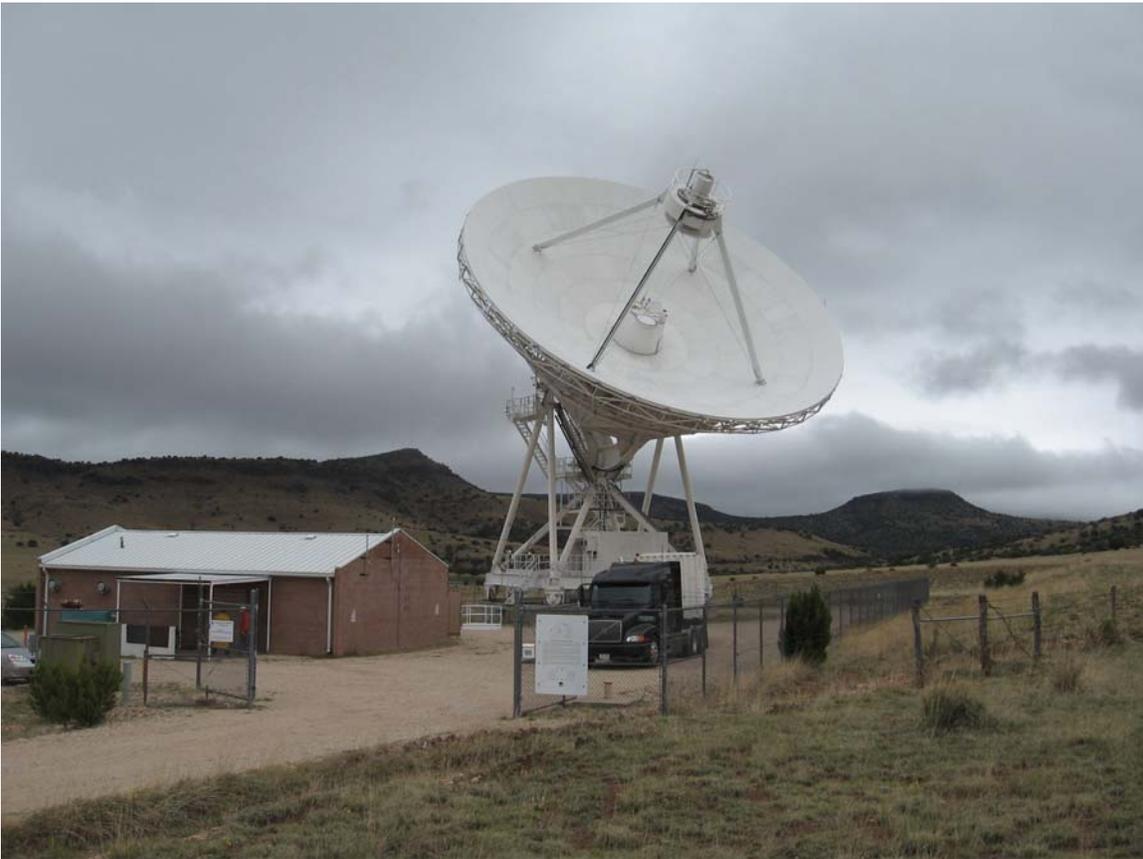
FRM was given a thorough inspection. The flex shaft was replaced 1 year prior to the maintenance visit. Rotation axis had been previously modified to operate on the West position feedback motor only. The sub reflector was previously rebalanced. The snow tarp was removed and three 1 inch drain holes were drilled in the center of the sub reflector for extra drainage.
