VLBA Antenna Memo Series No. 89

Azimuth Rail Repair at Fort Davis, Texas
June 17 – June 25, 2013

J. E. Thunborg
July 10, 2013

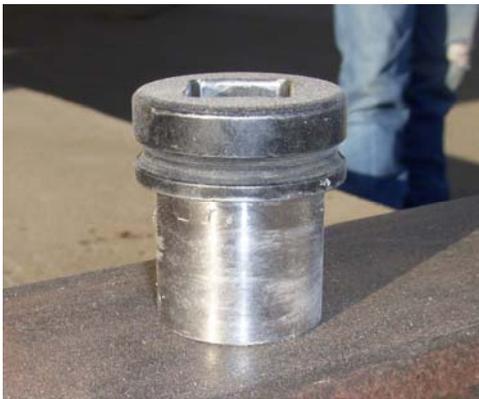
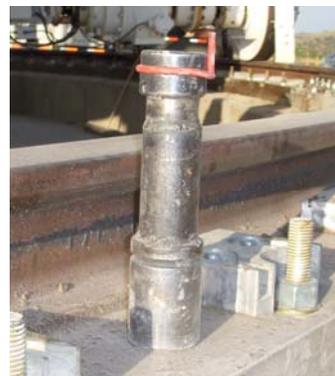
We removed the rail clips, splice bars and rail plate nuts. The rail clip nuts are recessed in a pocket that is too small for a traditional socket. Therefore we used a 1 ¼ “socket with the outer diameter turned down to a diameter of less than 1 13/16”. The 1”-8 unc studs that hold the rail plates down are sufficiently long that a traditional socket cannot be used. We fabricated a special deep well socket by welding a short piece of pipe between two sockets. Two of these deep sockets are needed as the rail plate nuts can be either 1 ½ or 1 5/8 wrench size.

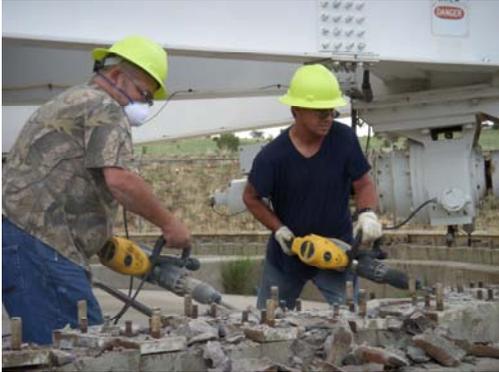
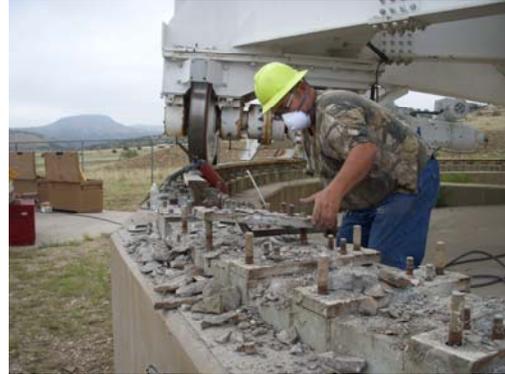
We used demolition hammers to loosen and remove the rail plates.

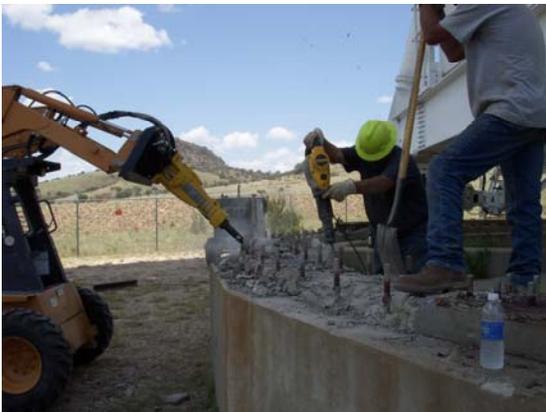
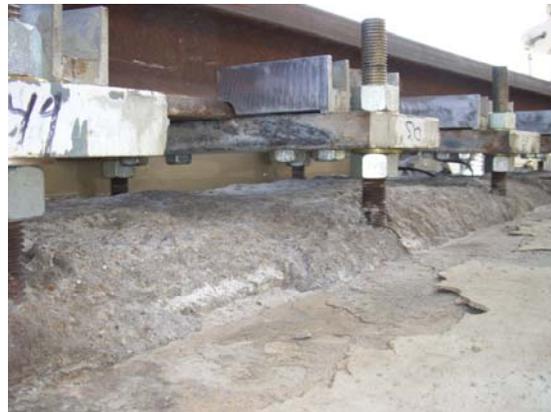
The old grout was removed to a depth of at least 2" below the rail plates.

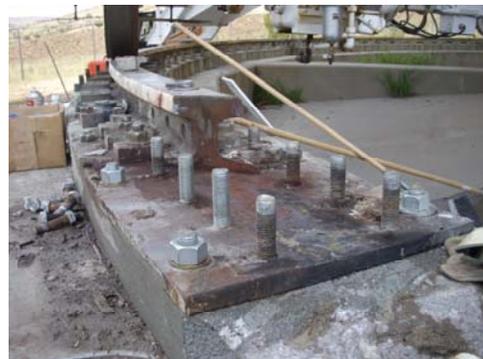
The Vulchem, grout and rust was then scraped from the rail clips and rail plates. The tops of the rail plates were then sanded smooth to facilitate alignment of the rail. The Vulchem was very hard to remove from the rail clip counter bores. We used a 2" cup brush for this task but it would be prudent to design a tool for this on the next rail replacement. The splice plates were also cleaned and sanded smooth.

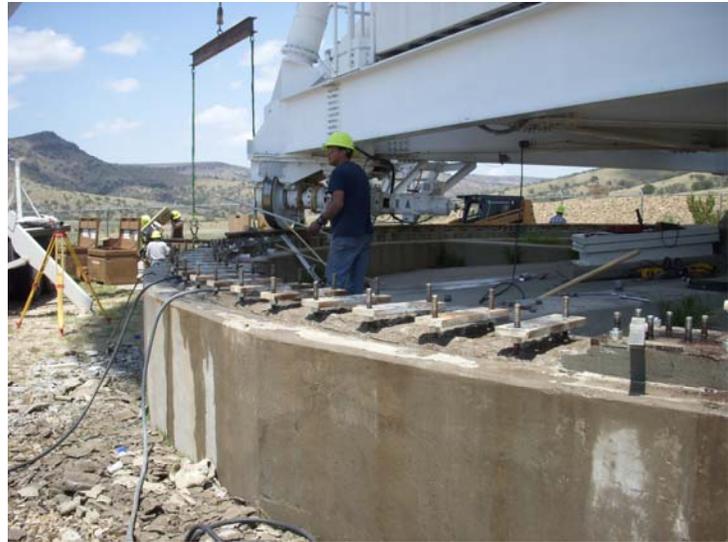
The Grout requires a clean surface free of all grease, oil and old material for proper bonding. Therefore, a pressure washer was used to remove all loose grout, dust and oil from the foundation. The foundation was then thoroughly dried using compressed air.

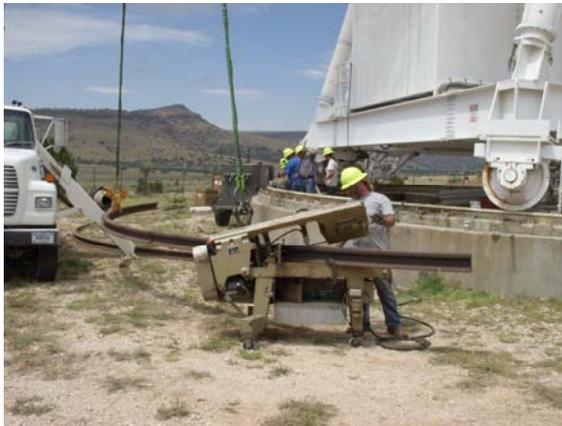
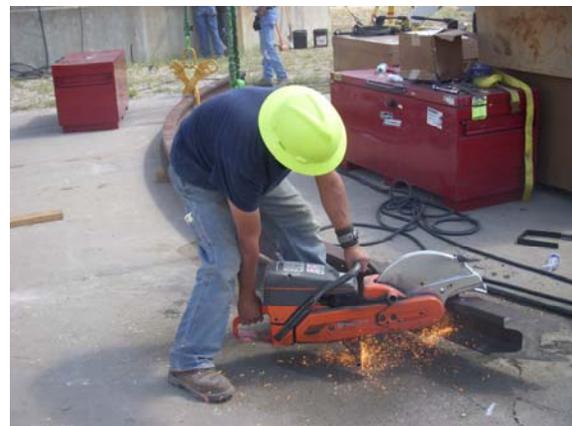
Cutting the rail sections to the correct angle and length proved to be more difficult than expected. The rail is made of alloy steel that does not appear to be homogeneous. Hard spots within the steel made it impossible to cut the rail with the horizontal band saw that we brought along for this purpose. Therefore, we were forced to cut the rail with a hand held abrasive wheel saw. An adjustable angle guide for the abrasive wheel saw should be designed and built for the next rail replacement.

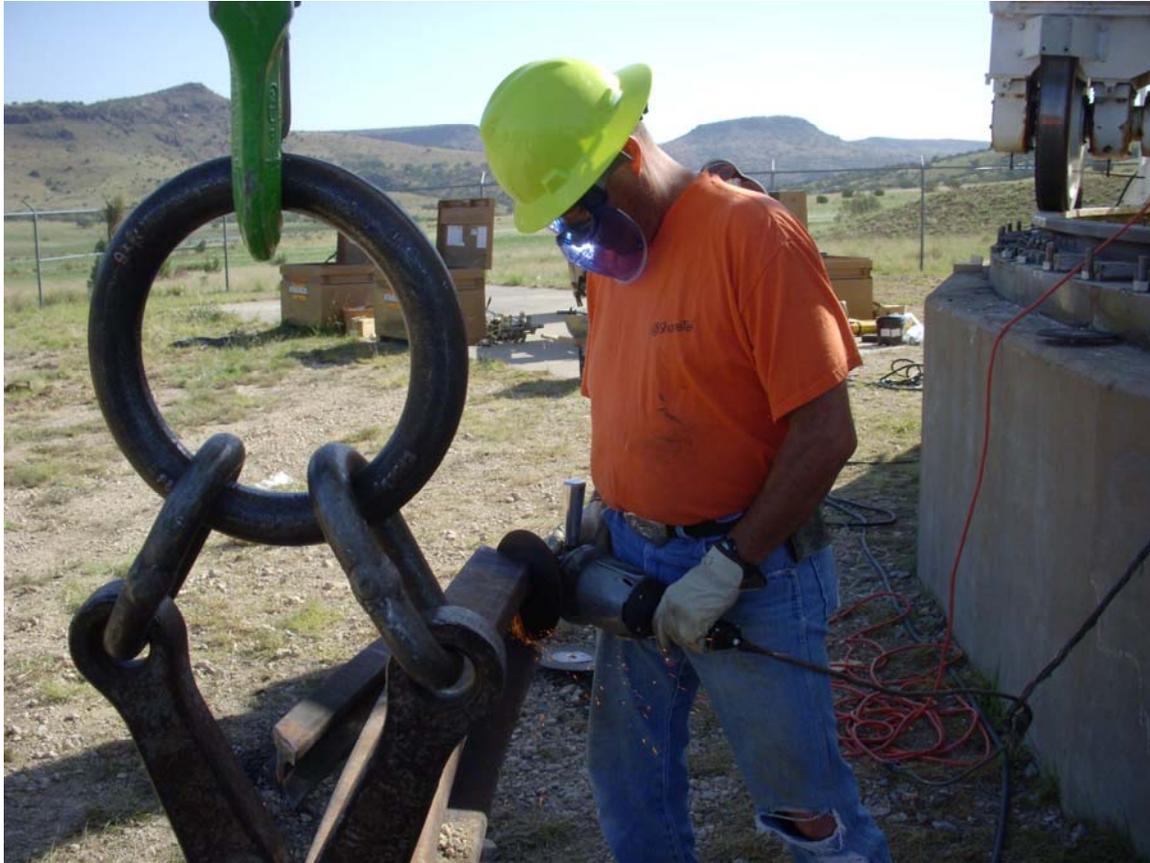
After the rail was cut to the approximate length and angle, a hand held grinder was used to bring the rail to its final dimensions.

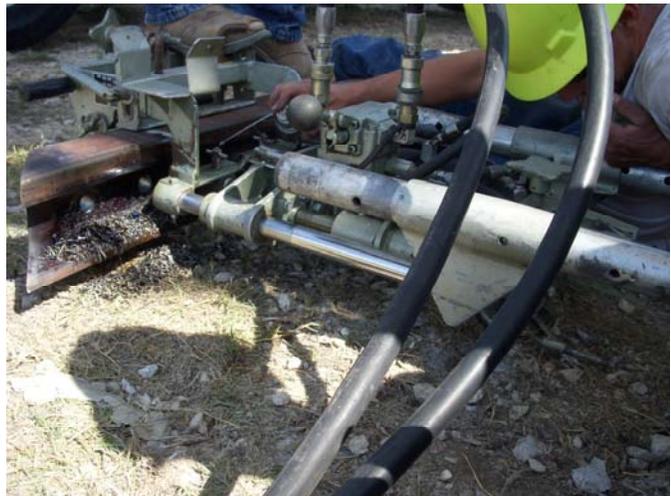
The next step in the process was to use a hydraulic rail drill to bore the 1-3/16" holes needed to accommodate the splice bar bolts. The hydraulic power unit needed to supply oil to the drill would not start, so we modified the drill so that it could be powered with the skid loader hydraulic system. This modification worked quite well and may become the preferred method to power the rail drill.

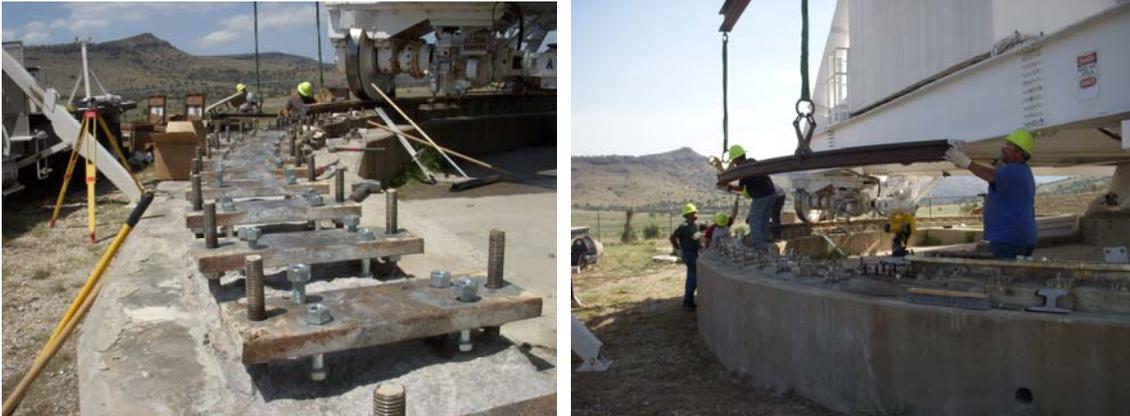
The rail plates were reinstalled and roughly leveled using an optical level. The rail was then set in place.

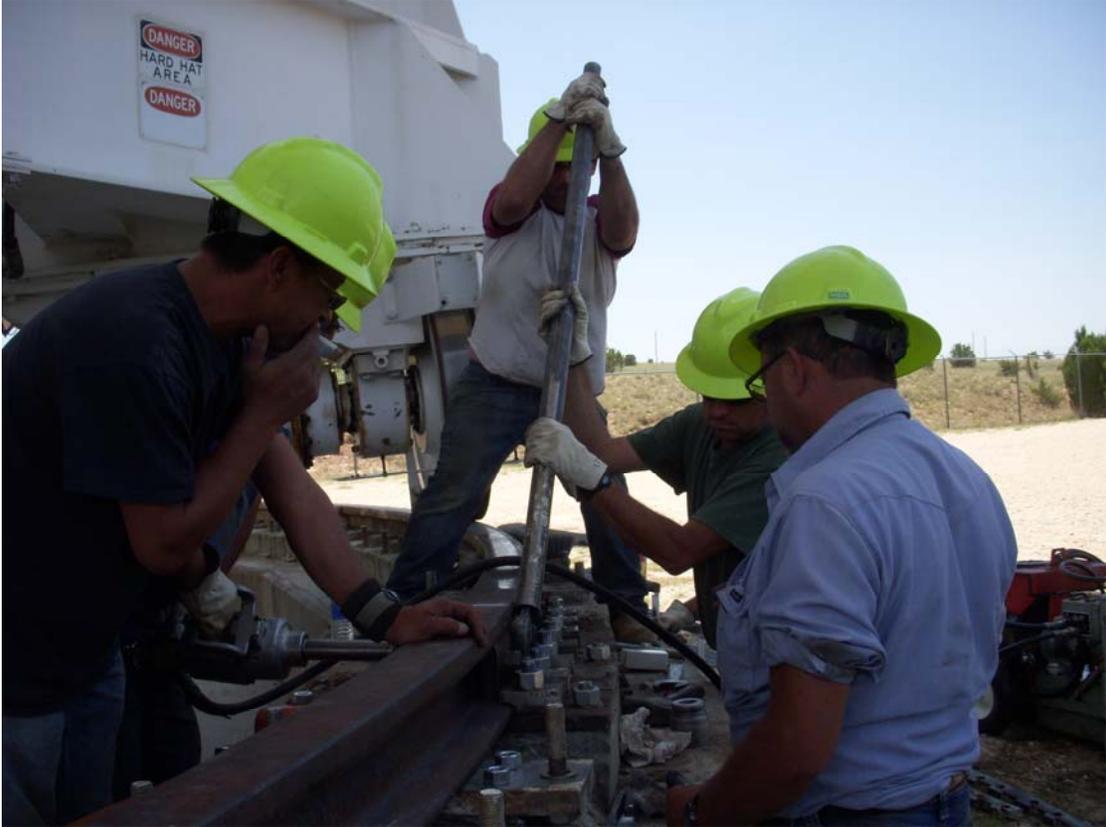
The splice bars and splice plate clamps were then tightened on the existing rail and loosely installed on the new rail. This allows movement along the rail as the rail was forced into the proper radius using the skid loader to supply the driving force.

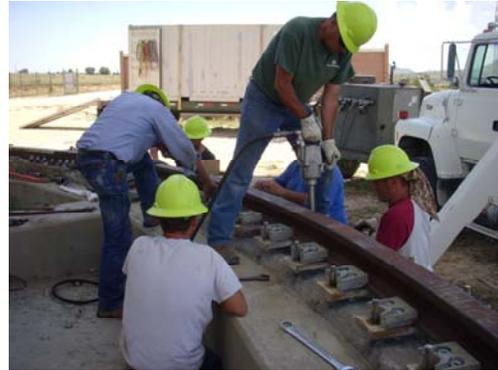
Once the rail was properly positioned, the rail clips were installed and all the splice bar bolts and clamps were then properly torqued.

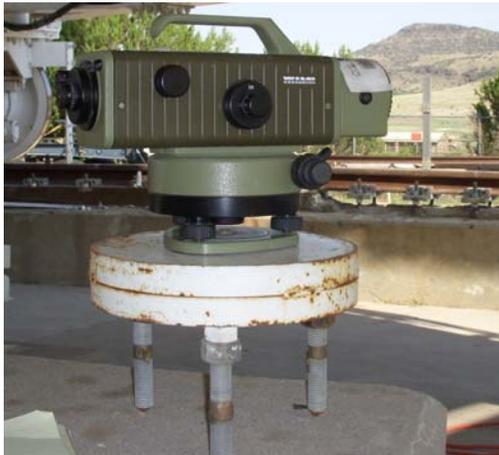
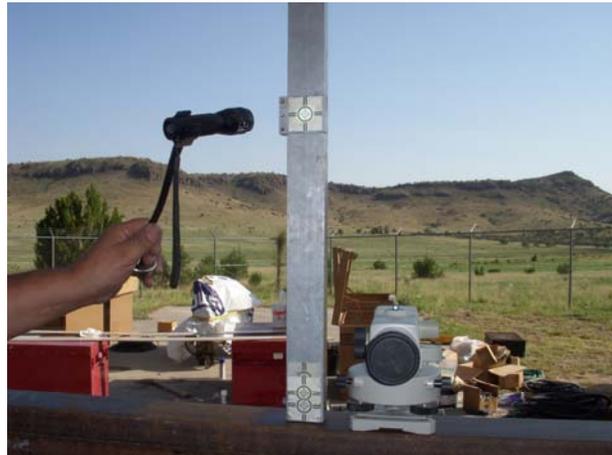
A precision optical level positioned near the pintle bearing and aimed at a target on the rail was used to set the rail to the proper height. A small portable light was used to illuminate the target. The level bubble on another optical level was used to level the rail from side to side.

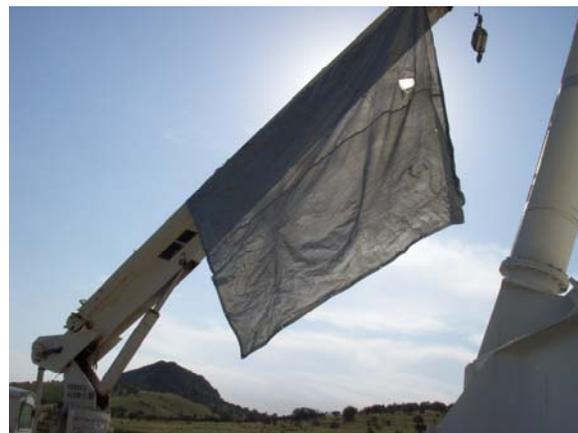
Great care was used to ensure that the rail was set to the correct height before grouting. The rail measurements measured in Section 3.1 were input in an excel spreadsheet that used a least squares curve fit to generate the proper heights to minimize rail flatness with the overall rail tilt removed. The rail was kept shaded during measuring to minimize thermal distortions from solar heating.

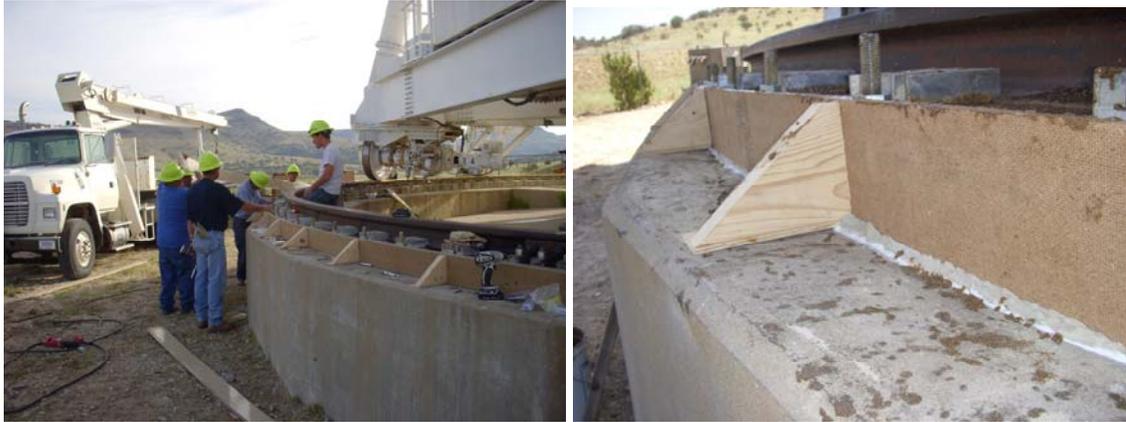
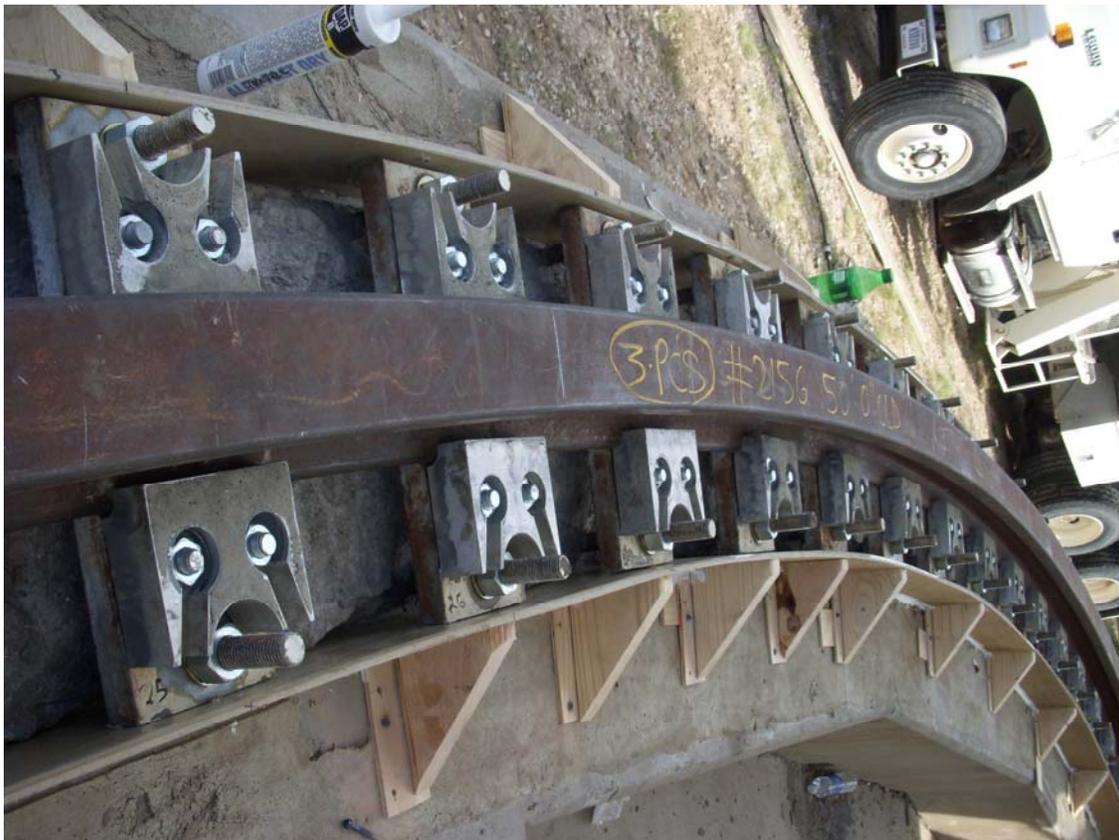
6" Masonite house trim coated with packing tape was used to create forms. The Masonite forms were then secured to the foundation using "Blue Screws" and wood wedges..

Silicone caulk and caulk cord was used to seal the forms and prevent the grout from leaking out of the cracks. We found that the caulk cord worked best as we did not have sufficient time to allow the silicone caulk to dry.

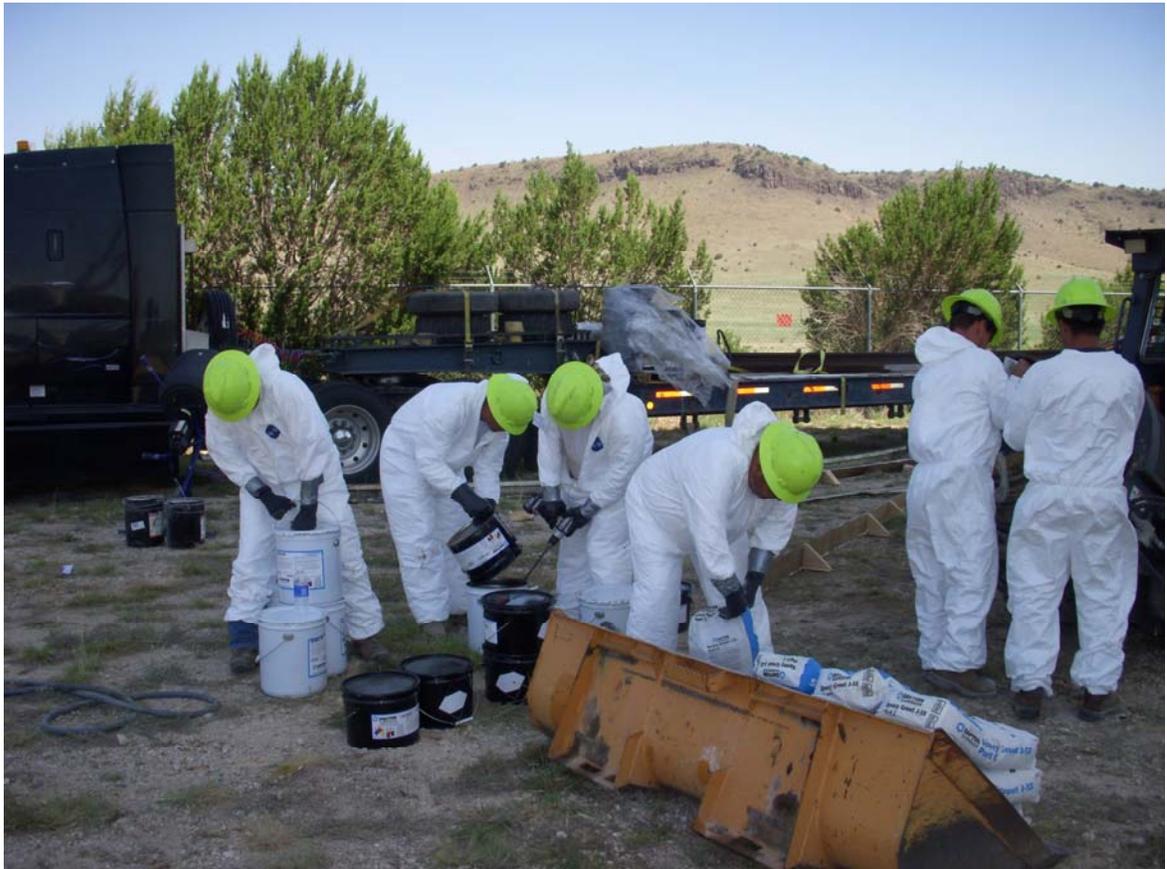
Parts A and B of the grout were combined and thoroughly mixed before being combined with part C in a skid loader cement mixer. Two 2 cu ft. units of grout were mixed at a time.

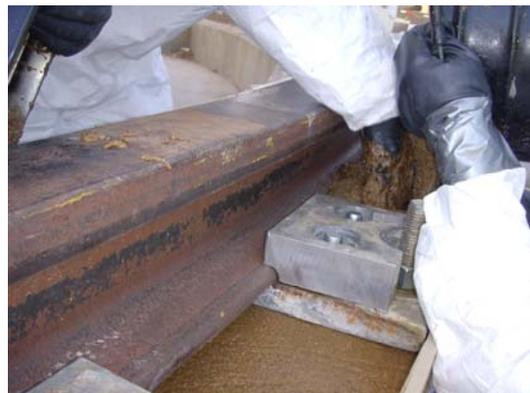
After thoroughly mixing the grout, It was loaded into 5 gallon pails and poured into the forms. The grout was always poured from one side of the rail and then allowed to flow under the rail and rail plates. This procedure was followed to ensure that air did not become trapped under the rail or rail plates.

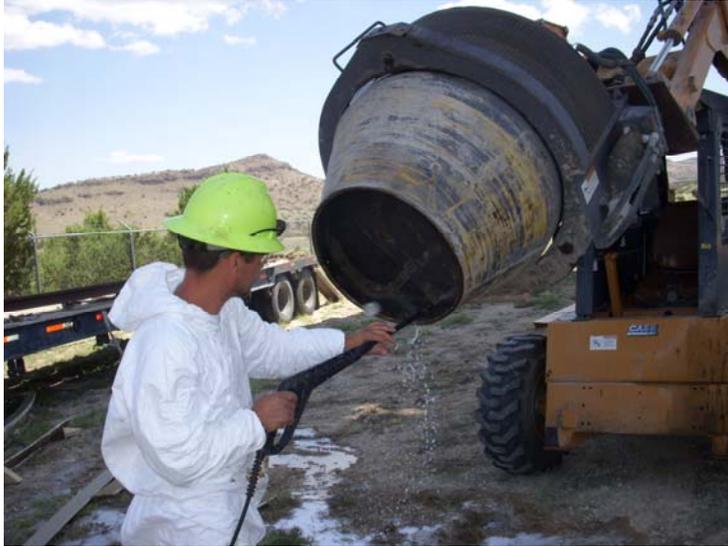
The working time of the grout at 95° F is approximately 45 minutes. Therefore, the cement mixer and all of the equipment had to be thoroughly cleaned soon after it was used.

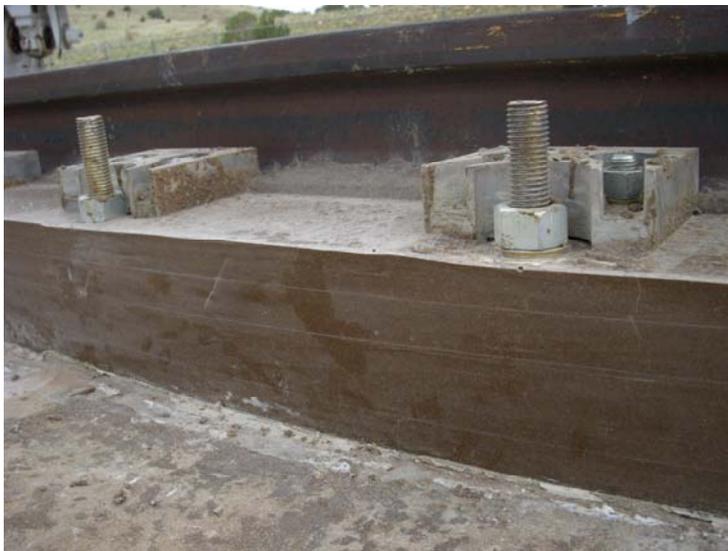
The grout was allowed to cure for 24 hours before the forms were removed and the antenna was allowed to roll over the azimuth rail. The antenna was then positioned so that the second rail could be replaced using the same procedure.
