National Radio Astronomy Observatory  
Socorro, NM 87801

EVLA Memorandum 41  
**Lightning Protection for Fiber Optic Cable**

T. Baldwin  
June 05, 2002

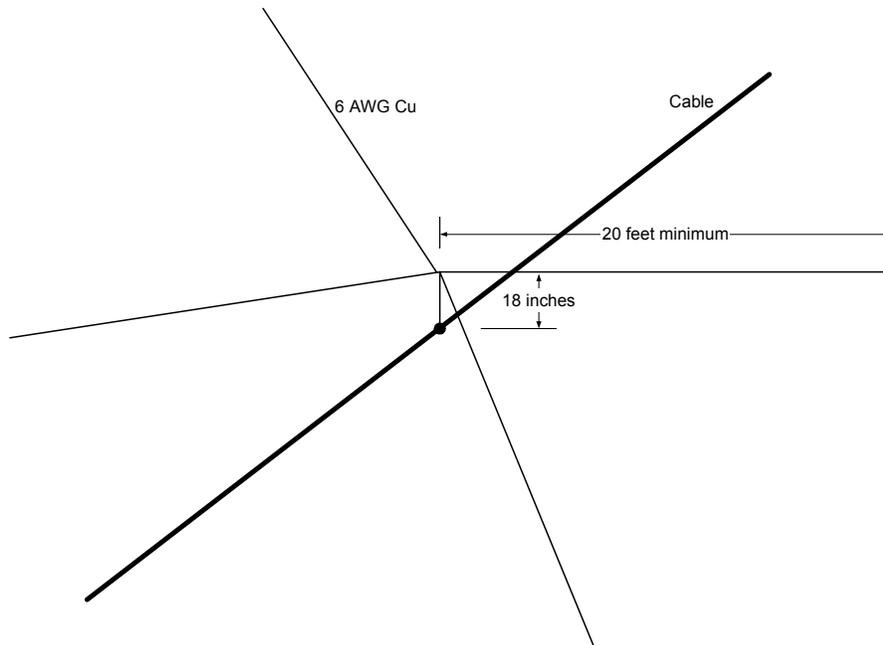
An alternate configuration is a four-leg star counterpoise as shown below. The ground resistance of such a counterpoise with four legs of 20 ft (6 m) each is still 4.5  $\Omega$ . The time to reduce the surge impedance to the dc resistance level is about 60 ns, or 250 times faster than the surge. There is insignificant advantage in using more than four legs.

Therefore, one of these two configurations is recommended, but a four-leg counterpoise is preferred. The wire used must be 6 AWG copper, the total length must be at least 80 feet long (25 meters), and it must be buried 18 inches (0.45 m) above the cable.

When a cable is broken between manholes and bonding to existing structures is not possible, additional shielding will be necessary. A ground rod or two is not sufficient because of the high soil resistivity at the VLA. Shielding in these cases takes the form of either a buried counterpoise wire bonded to the cable shield, or buried shield wires placed well above the cable. 6 AWG copper wire is sufficient for either configuration.
