VLBA TEST MEMO 66

FIXING THE 0.7° VLBA POINTING WOBBLE

Walter Brisken

August 28, 2001

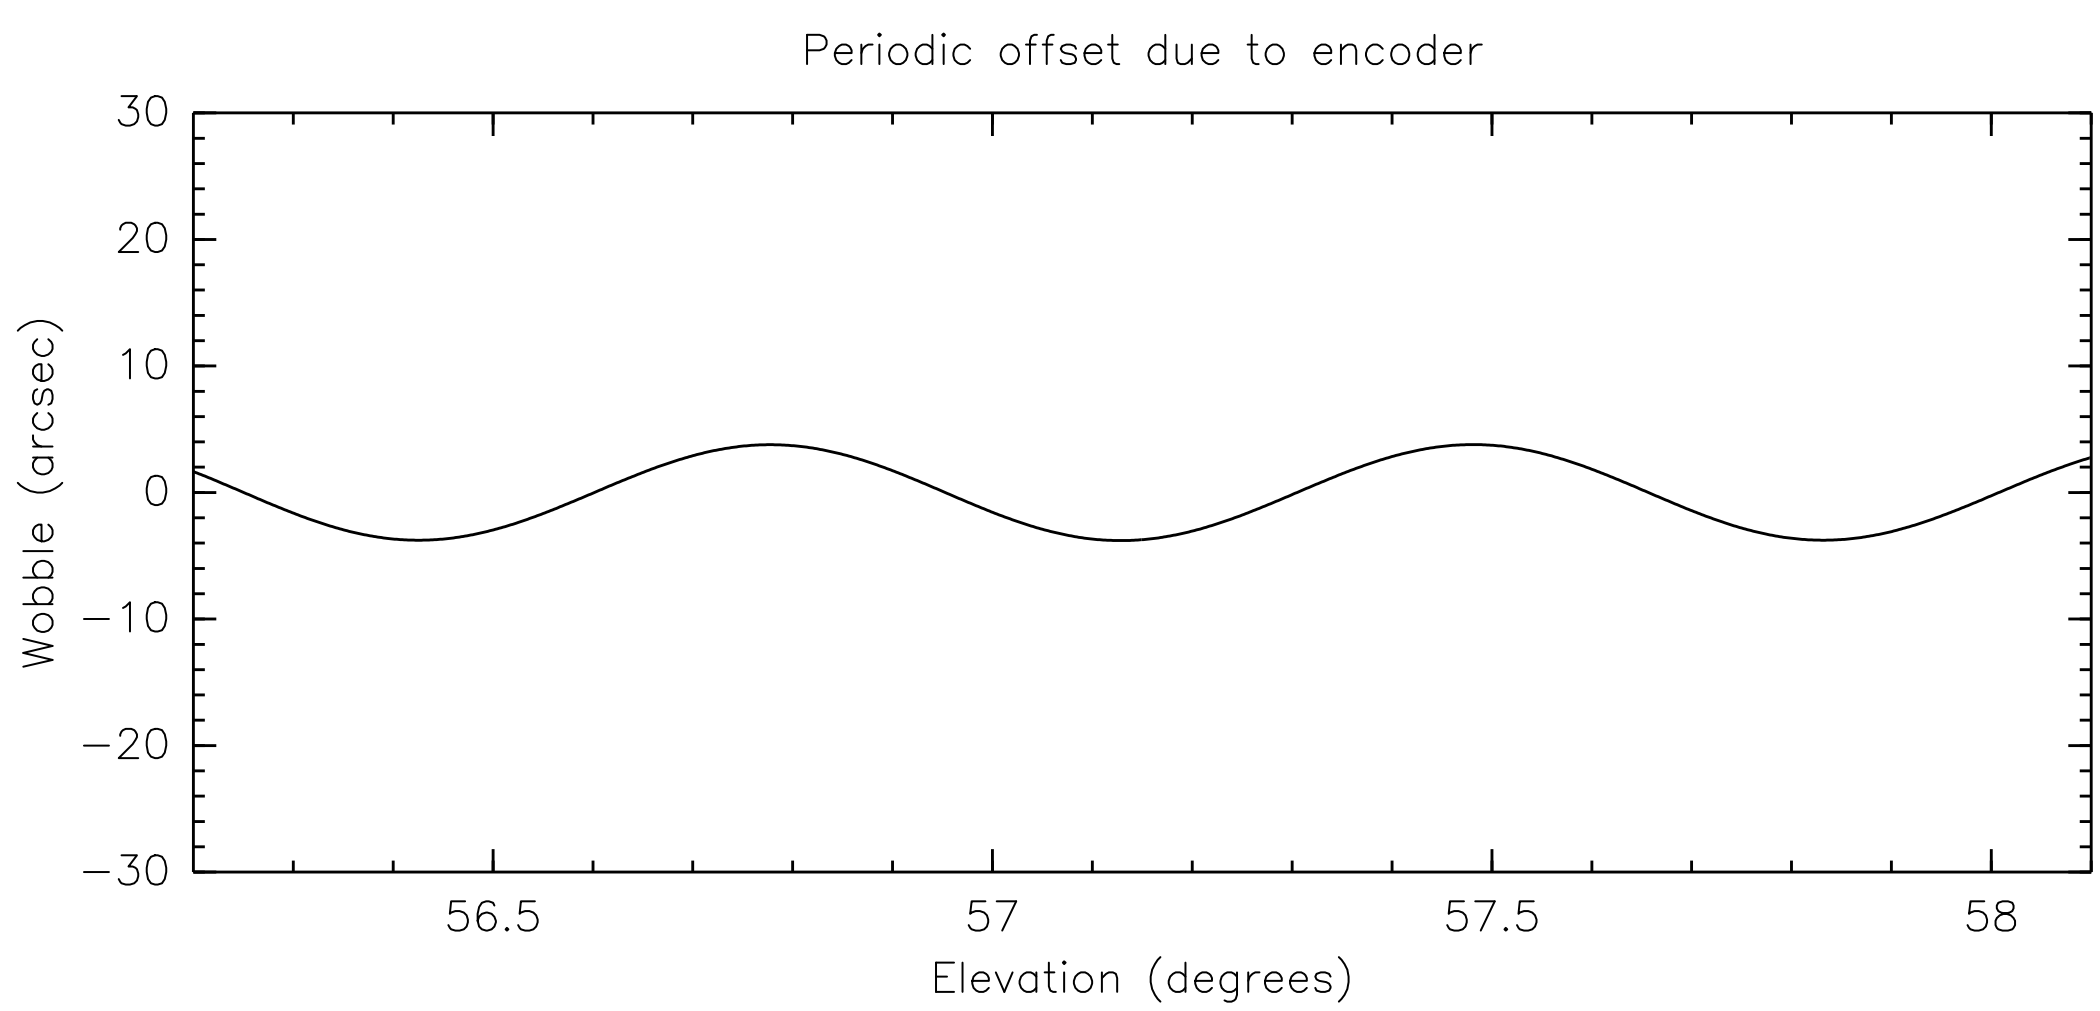
A pn3db test showed that Los Alamos had a 0.7° pointing wobble with roughly 8 arc-second peak-to-peak amplitude (see Fig. 2). The measurements made on the encoder converter/processor board also indicated an 8 arc-second wobble. The predicted wobble is shown in Fig. 1. After equalizing the X_{256} and Y_{256} gains, a second pn3db test was performed, showing no sign of the periodic wobble (see Fig. 3).

Figure 1: Predicted wobble pattern at Los Alamos for the measurements in Table 1.

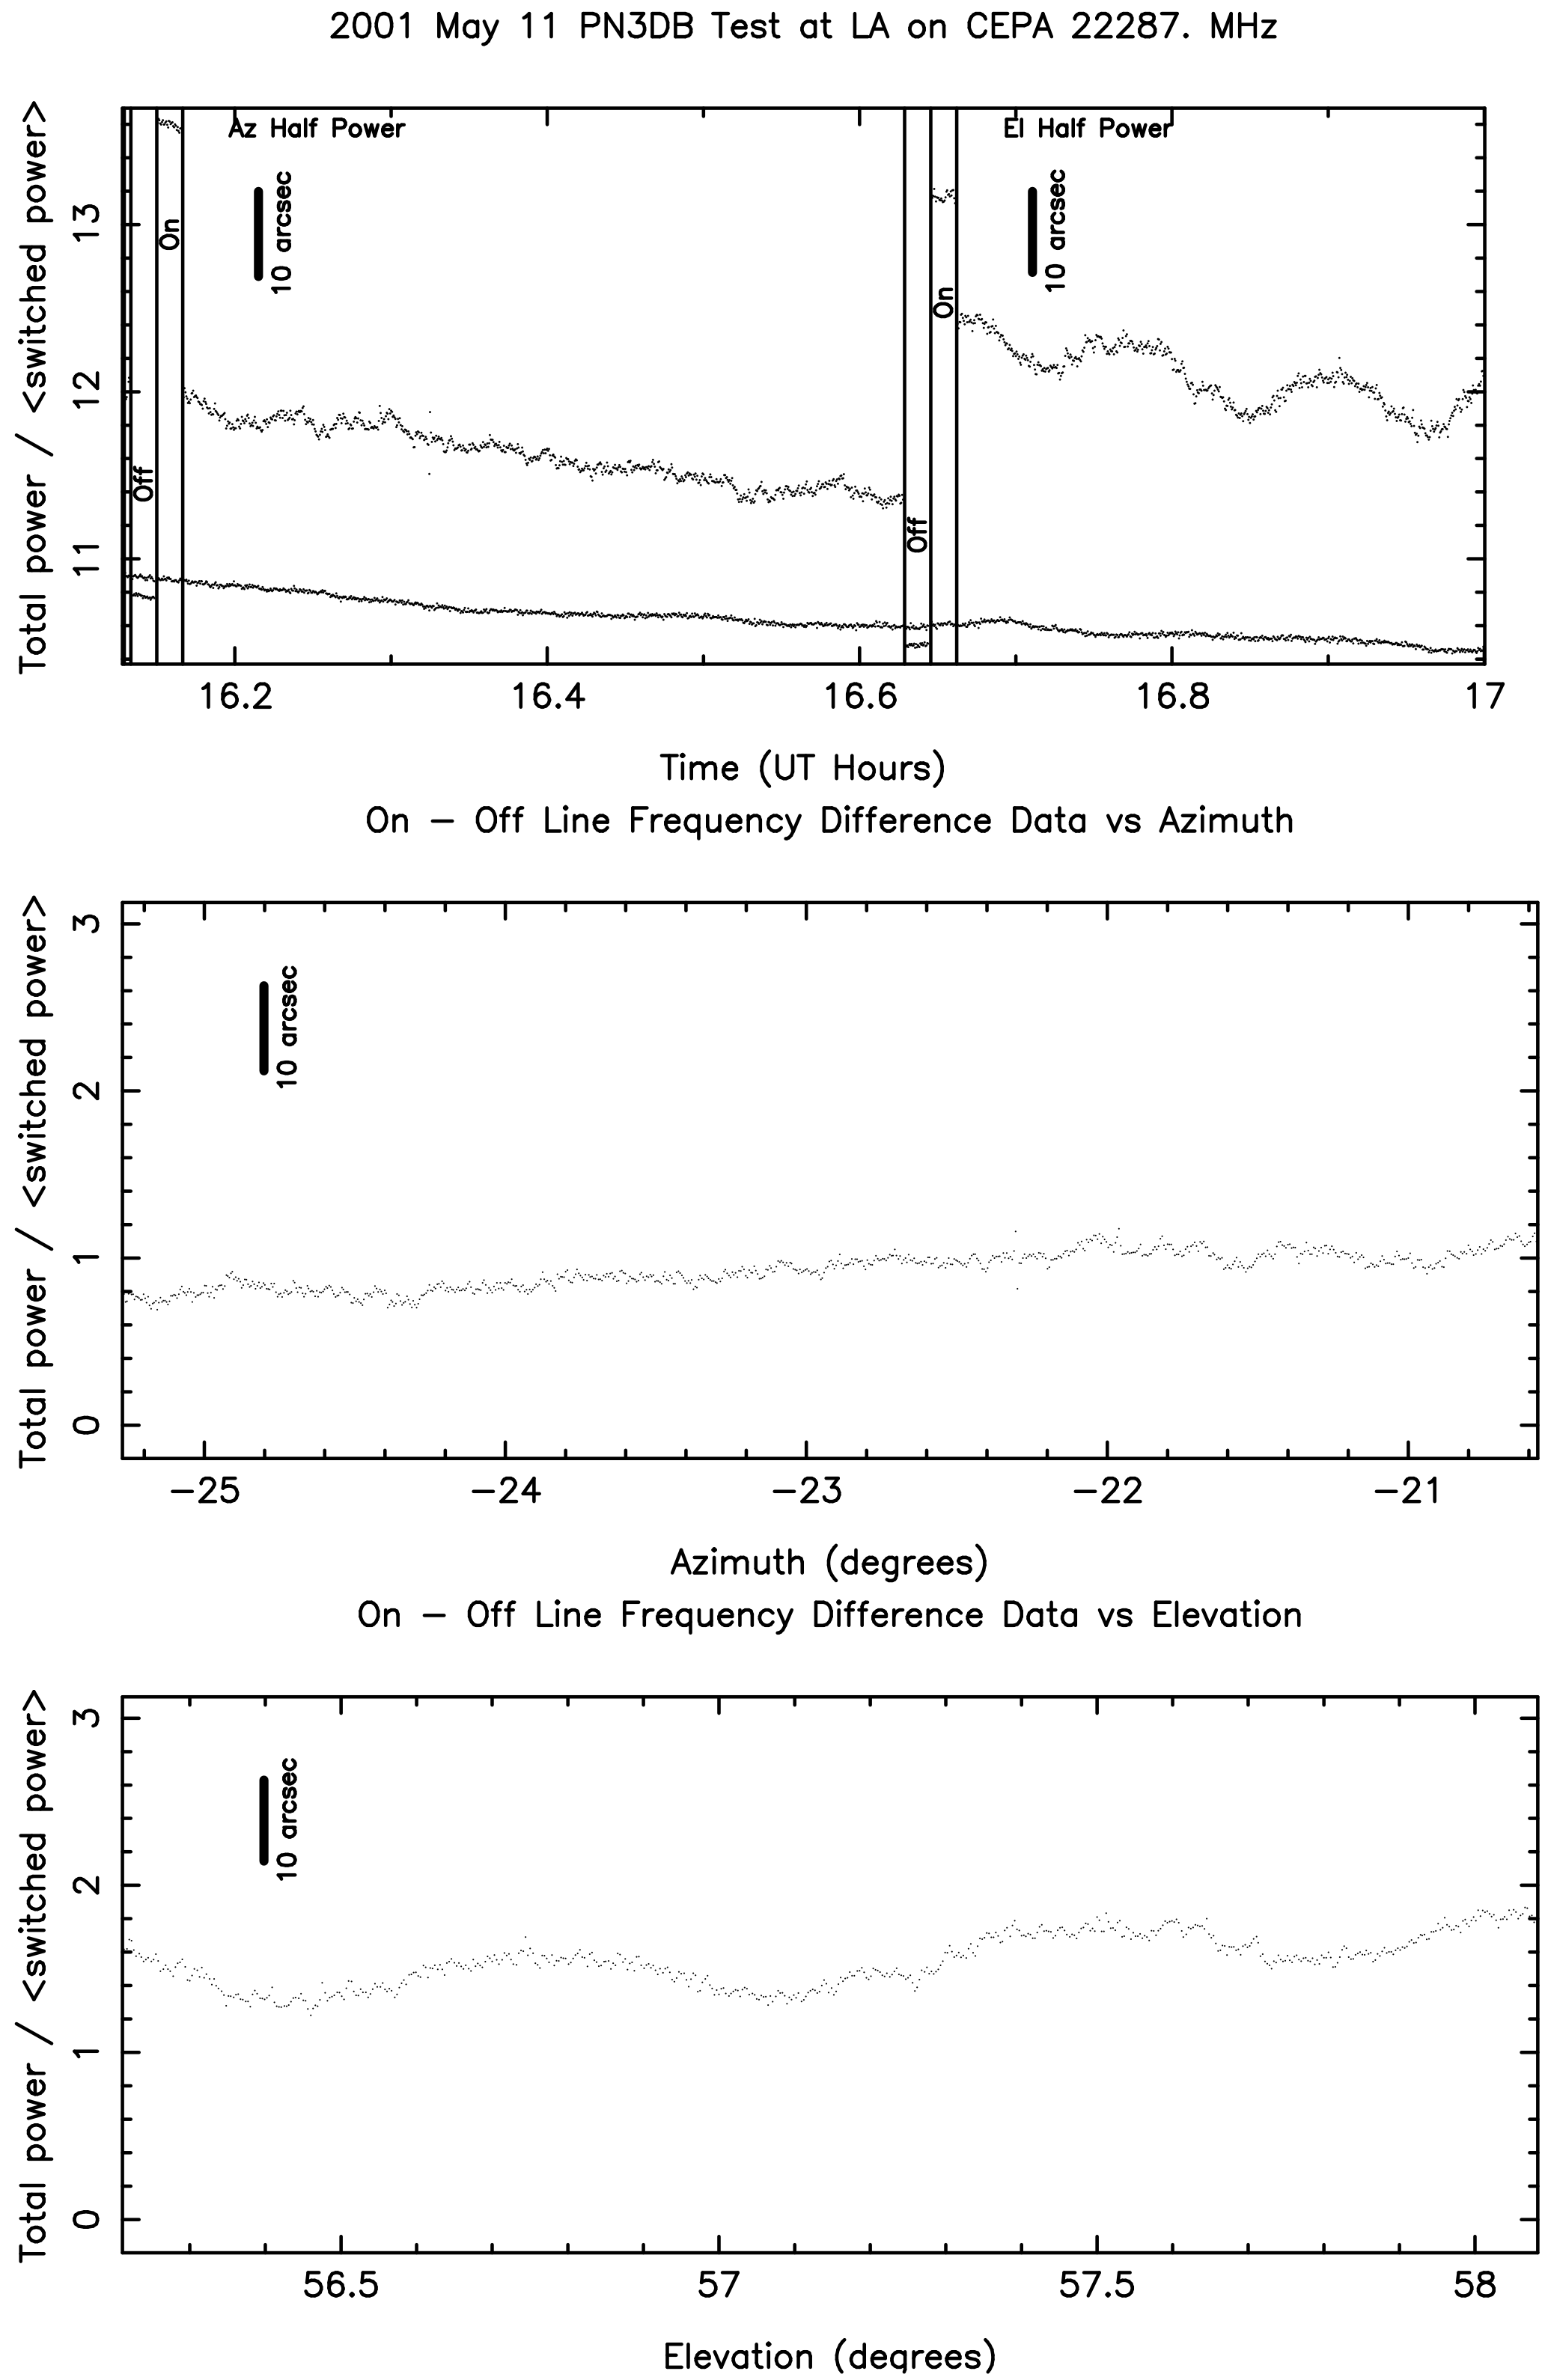
A periodic wobble at half the angular scale of the encoder, 0.7°, will arise if the peak-to-peak amplitudes of X_{256} and Y_{256} are not identical. Each signal passes through about 7 op-amps and more than 10 meters of cable *en route* to the digitizer. While the encoders may have been properly tuned prior to installation, combinations of aging components and differences in components on the converter/processor board are most certainly responsible for unequal amplitudes at the present date. A 1% difference in gain will produce a wobble with peak-to-peak amplitude of 8 arc-seconds, a signature very easily detected with a pn3db pointing test.

Figure 2: May 11, 2001 pn3db test on Los Alamos. Note 0.7° wobble in declination.

On the inductosyn preamp board, located within the encoder enclosure, there is a resistor for each of X_{256} and Y_{256} that controls the fine gain tuning. The schematic for this board states, "R5 & R18 are selected to match gain to within .02%". It is likely that these resistors were selected based on voltage measurements made on this board, not at the converter/processor board, meaning that the downstream electronics were left out of the calibration. In any case, one of these two resistors can be changed to equalize the amplitudes of X_{256} and Y_{256}. Installation a precision trim pot instead of a fixed-value resistor will make future tuning easier.

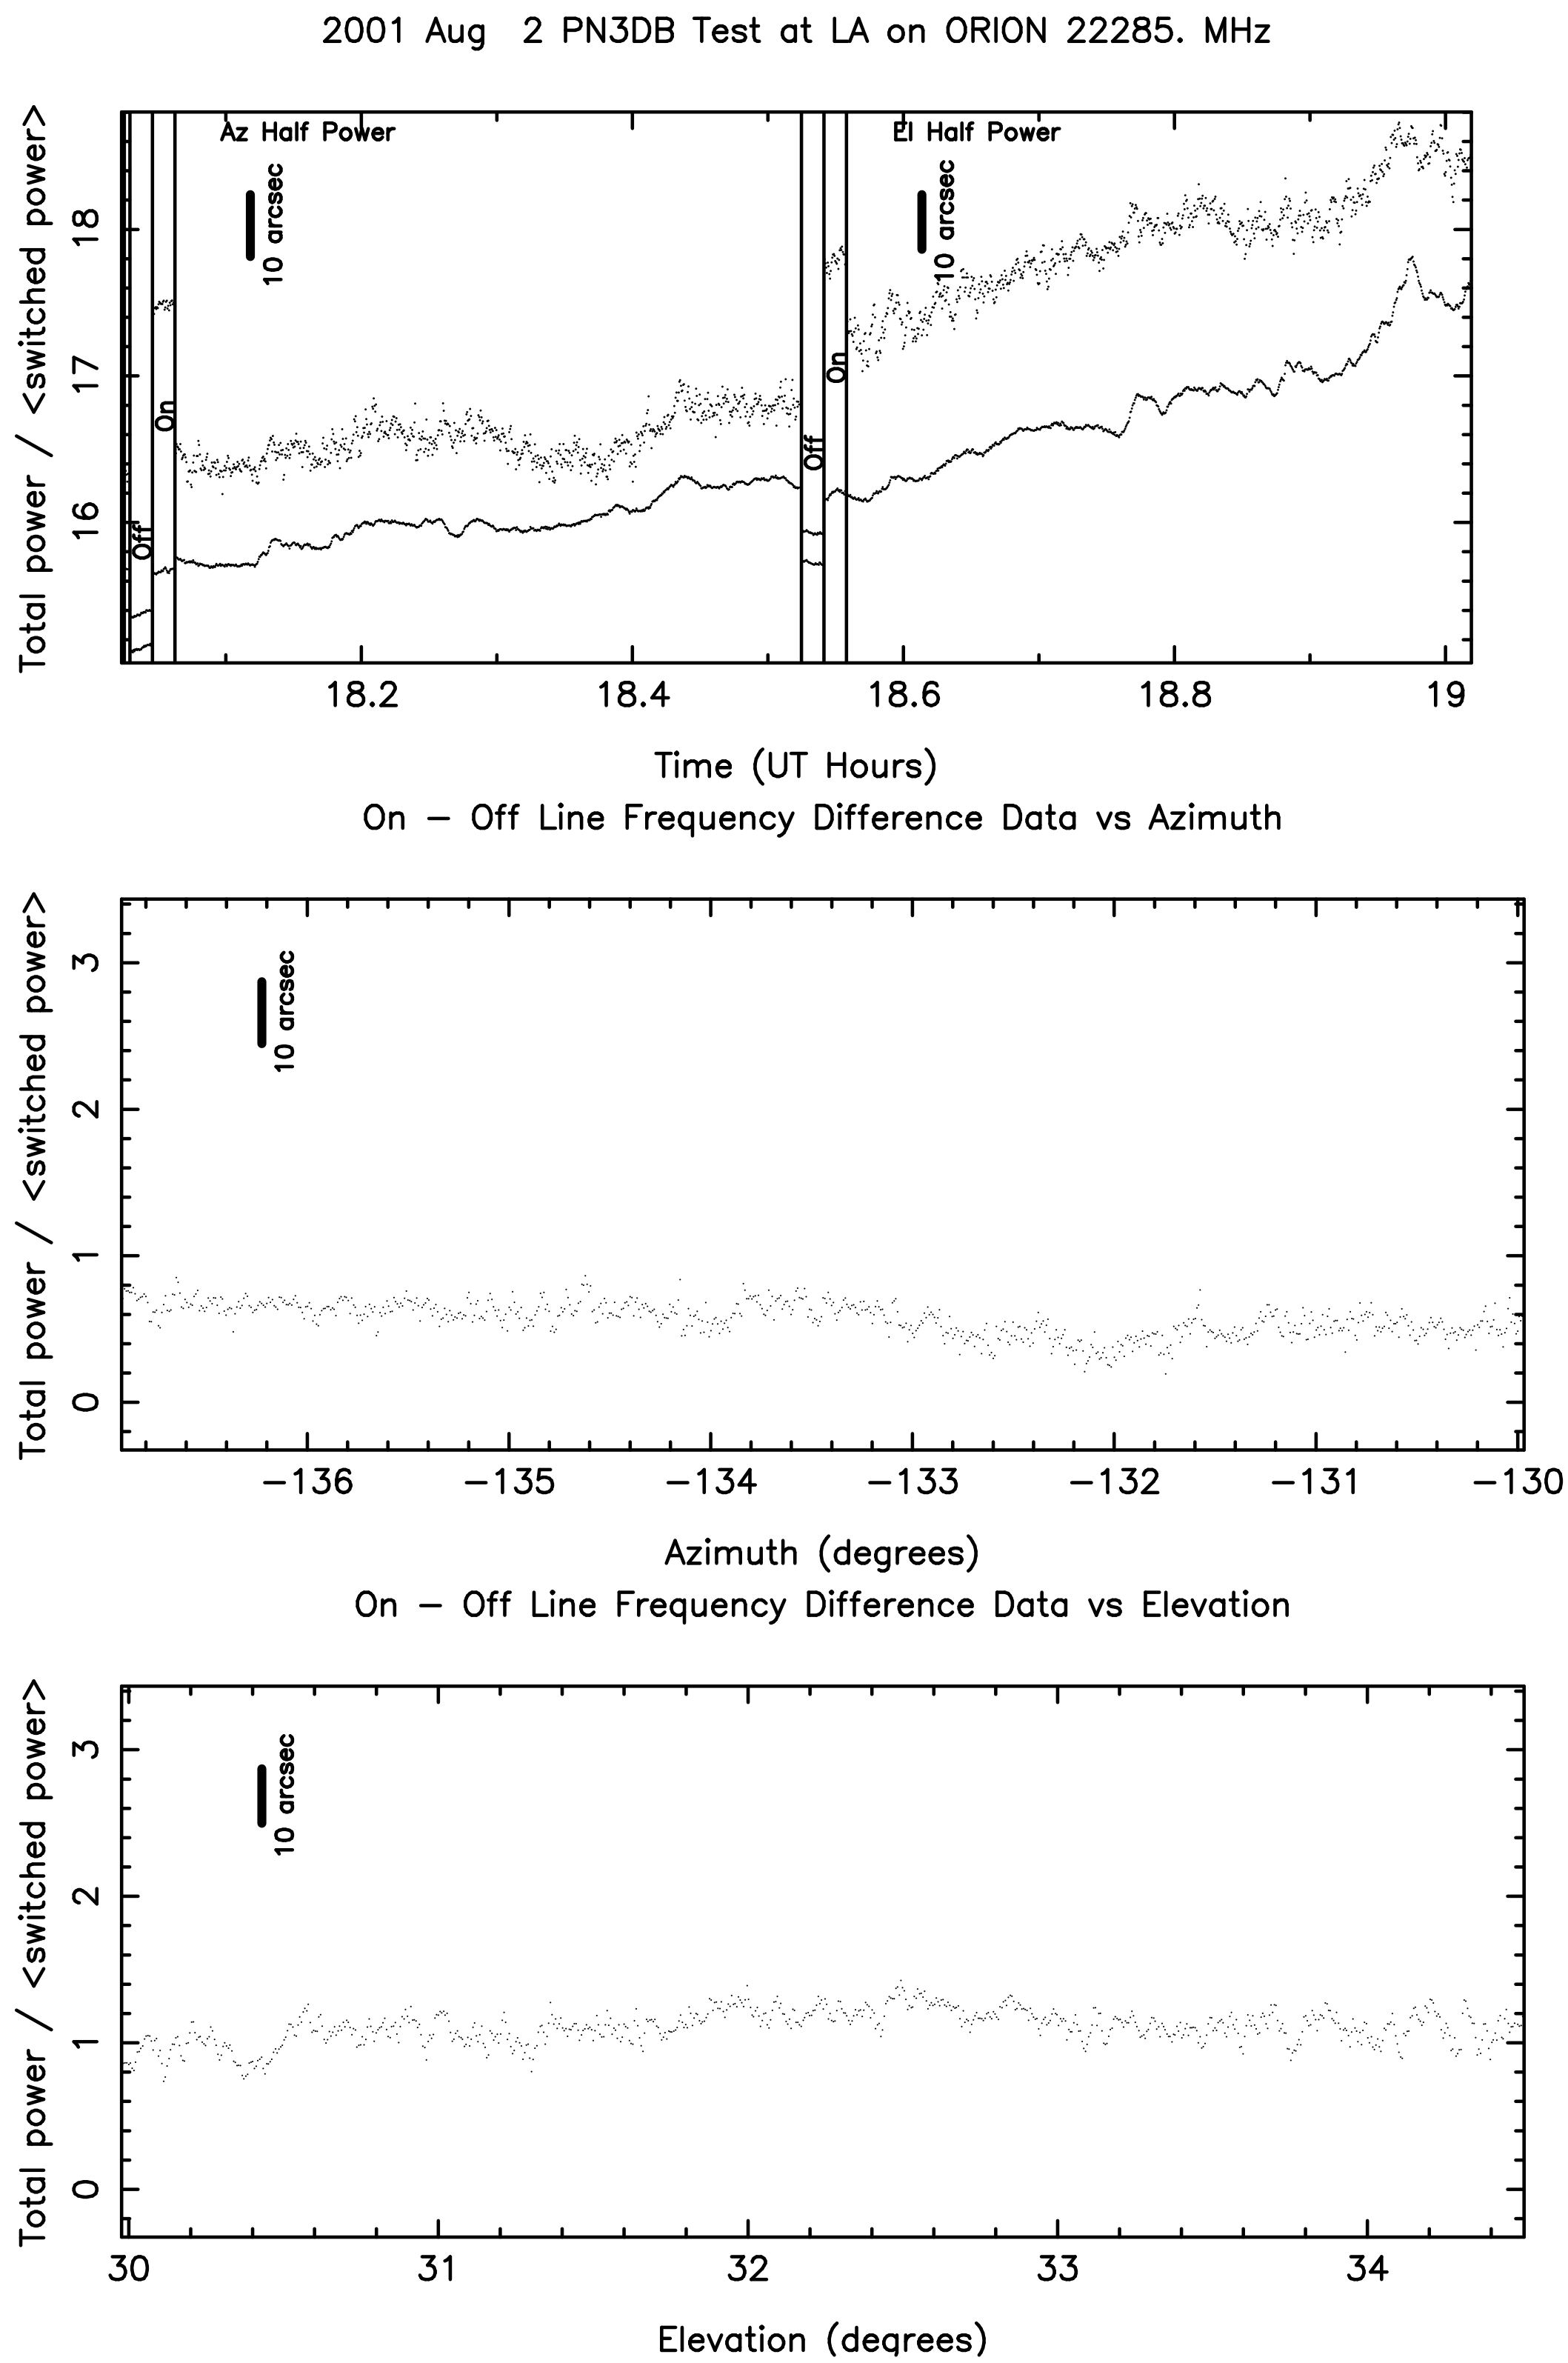
Figure 3: Aug 2, 2001 pn3db test on Los Alamos. The wobble is gone.

Paul Johnson tuned the elevation axis at Los Alamos. Before the tuning, the peak-to-peak amplitudes of X_{256} and Y_{256} were measured four times. The amplitudes were measured again after the tuning. These numbers appear in Table 1. It is encouraging that their ratio is constant to the precision of the meter over a two week period, indicating that tuning may not be required often.
