VLBA Test Memo No. # 54

Investigation of VLBA Azimuth Wheel Bearing Failures

J. E. Thunborg July, 1997

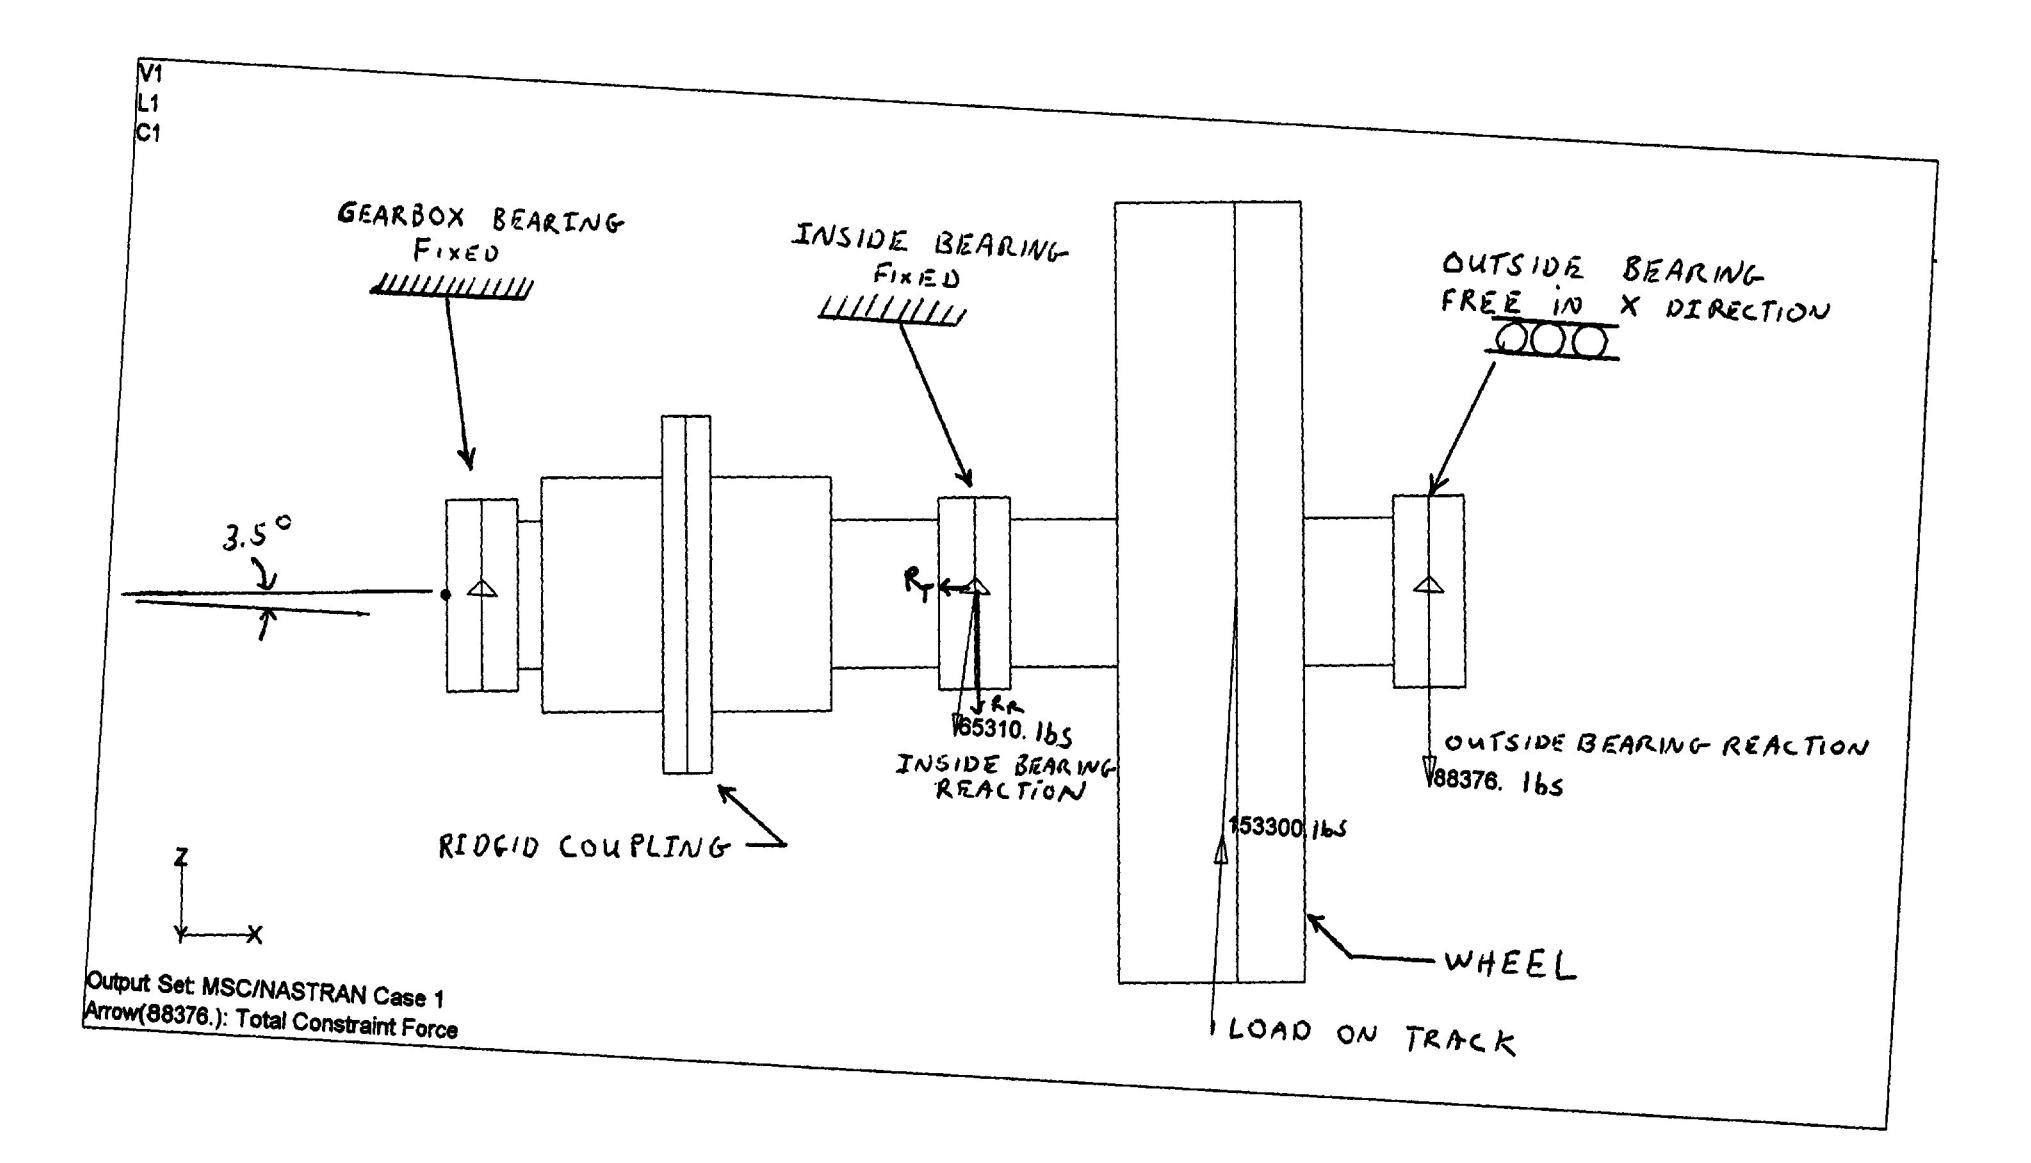
VLBA - AZIMUTH DRIVE WHEEL

In order to estimate the service life of the bearings, we must first understand the loads in the bearings. The dead weight (ignoring wind, track alignment, etc.) on the azimuth drive wheels is 153,300 lbs. In the ideal case this load is distributed as shown in Figure 1. The bearings at the gearbox are very stiff, tapered roller bearings. These bearings rigidly fix the drive shaft in all directions except rotation about the X-axis, which is constrained by the drive motors. The inside pillow block supports a Torrington number 23038 BR spherical roller bearing. This bearing constrains the shaft from moving along the Y and Z axes. A spacer ring was installed in this pillow block to constrain the axle from movement along the X-axis as well. The outside pillow block supports the same Torrington bearing, but the spacer is left out permitting motion along the X axis.

The axis of the axle is 3.5 degrees off horizontal. Therefore, a thrust load develops along the axle and the radial load is not divided equally between the bearings. The antennas were designed so that the thrust is taken by the inside bearing, which has the lighter radial load. The bearing life calculation in Appendix A shows that if the inside bearing bears the thrust load, then the equivalent load in the bearings is balanced and both bearings should have approximately equal life. However, I have noticed that a large percentage of the outside bearing to bear a portion of the thrust load, which added to its already high radial load greatly shortens its life. This does however extend the life of the inside bearing, which is much harder to replace.

Up to this point I have only discussed azimuth drive wheels. The idler wheels are supported by the same Torrington 23038 BR bearings as the drive wheels. A spacer is also placed in the inside pillow block to ensure that the thrust will be reacted against by the inside bearing. The dead weight (ignoring wind, track alignment, etc.) on the idler wheels is 75,900 lb.. The reaction forces within the bearings are 43,700 lb. for the outside bearing and 32,000 lb. for the inside. The inside bearing also takes a 4,600 lb. thrust load. Under this relatively light loading, the idler bearings should greatly outlast the drive wheels.
