EDTN 202

Further Measurements on the Haas Super Mini Mill

S/N 40150, NRAO PO 207121

7 December 2005

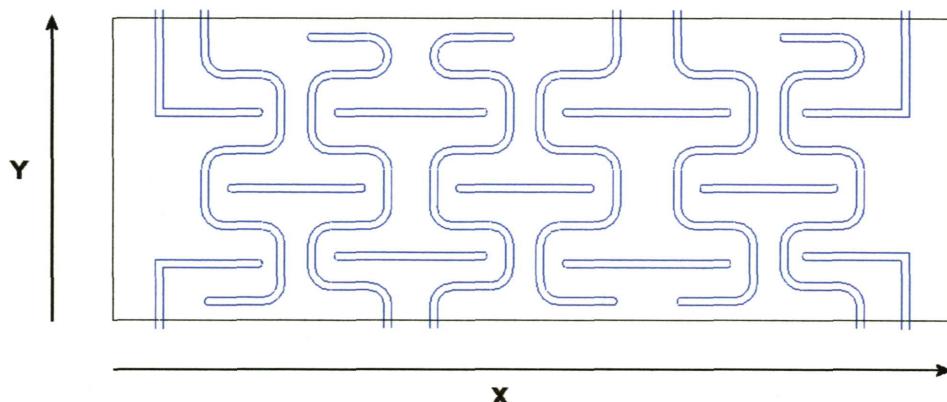
Fig. 1. Test pattern used in earlier measurements [1].

In earlier measurements, it was found that the uniformity of milled channel widths in the test pattern shown in Fig. 1 was well outside the $\pm 0.0002"$ expected from the specified position accuracy and repeatability of the Haas machine, but only in the Y-direction. The distribution of channel widths in the Y-direction, measured by microscope, for the first test piece is shown in Fig. 2. These measurements are described in detail in the report on our earlier tests [1].

With the machine's Y-axis compensation parameters set to the newly optimized values, another test piece was machined to the original test pattern (Fig. 1). The channel widths in the Y-direction, measured by microscope, are shown in Figs. 11 and 12.

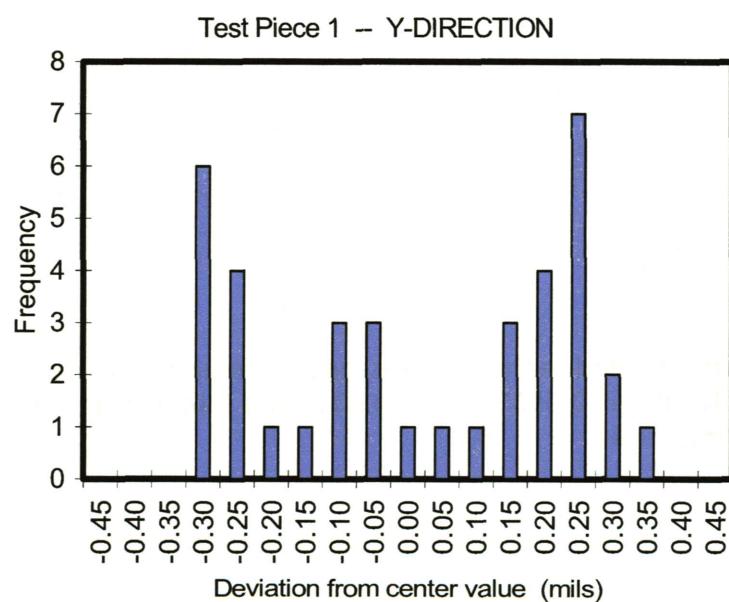
Fig. 2. Distribution of channel widths in original tests [1]. Measured by microscope.

Fig. 4 shows the widths of the channels at each of the measurement points as deduced from the laser measurements of the machine motion. The range of channel widths and the double-peaked distribution are similar to the earlier measurements on cut metal test pieces (Fig. 2). Fig. 5 shows the same data as Fig. 4 but as a function of channel width error. In both Figs. 4 and 5, the Haas factory settings were used for the backlash (28) and friction (80) compensation parameters.

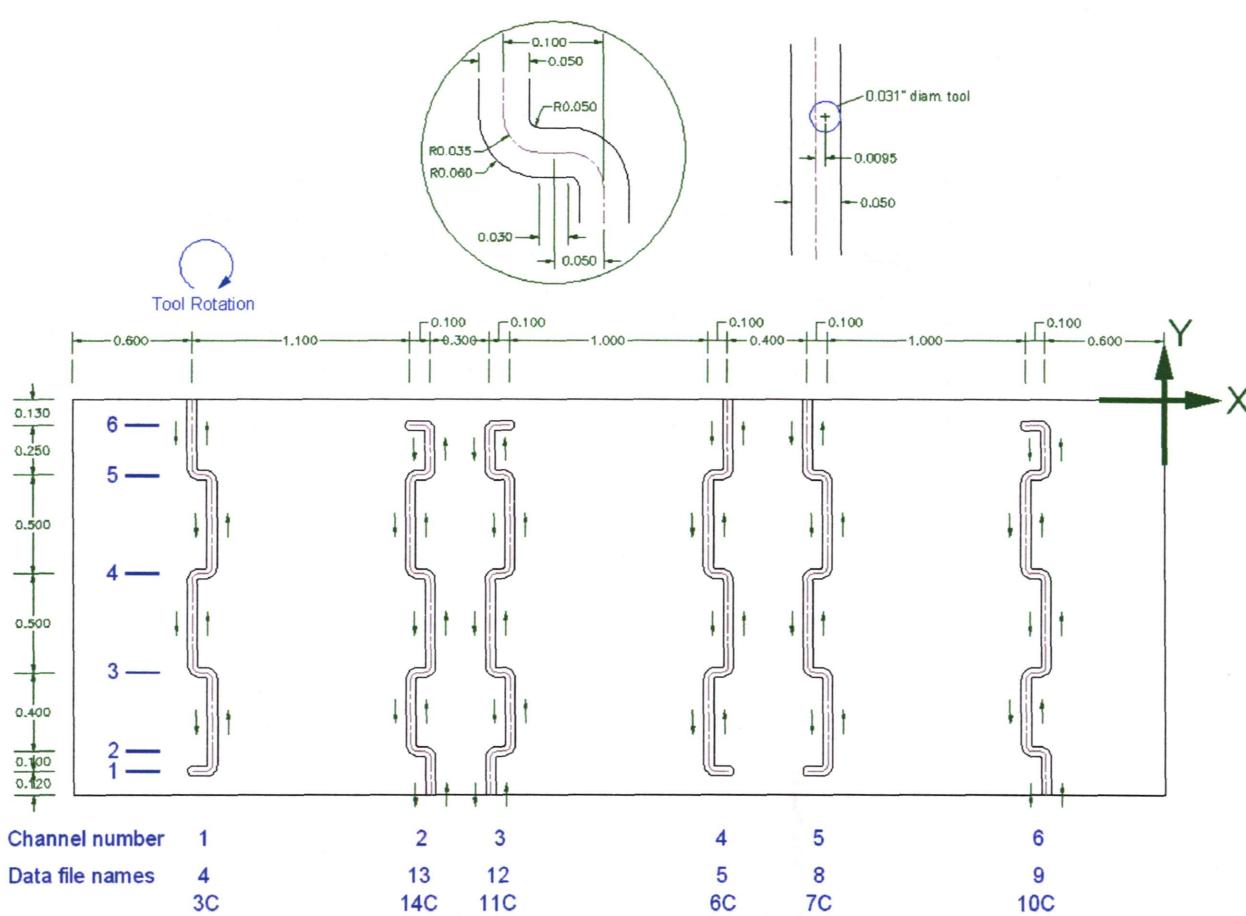
Fig. 3. Test paths used in the present measurements. The nominal channel widths are all 0.050", and a 0.031" end mill is assumed, operated in climb-cutting mode.

The laser interferometer was set up to measure the Y-position of the table of the mill relative to the (fixed) spindle housing. The interferometer allows the table to be moved in the X-direction by $\pm 0.075"$ without loss of measurement accuracy, so the mill was programmed to follow a series of meander paths as indicated in Fig. 3, where the X-motion of the tool in each channel is $\pm 0.0595"$. The mill was stopped in the middle of each X-cut and its Y-position sent to a computer which also recorded the corresponding reading of the laser interferometer. The paths are similar to those in the earlier test pieces except for the reduced X-motion in each channel. The nominal channel widths are all 0.050", and a 0.031" end mill is assumed, operated in climb-cutting mode.

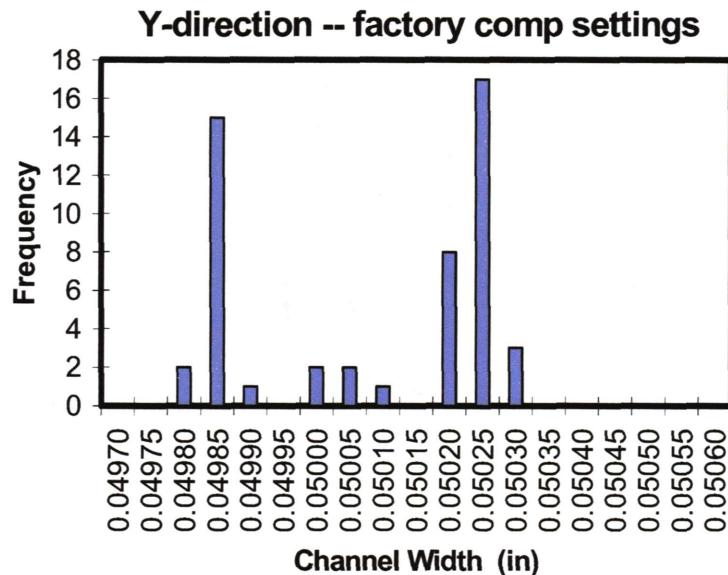
Fig. 4. Laser measurements of machine motions corresponding to channel widths in the Y-direction. (Backlash comp. 28, friction comp. 80.)

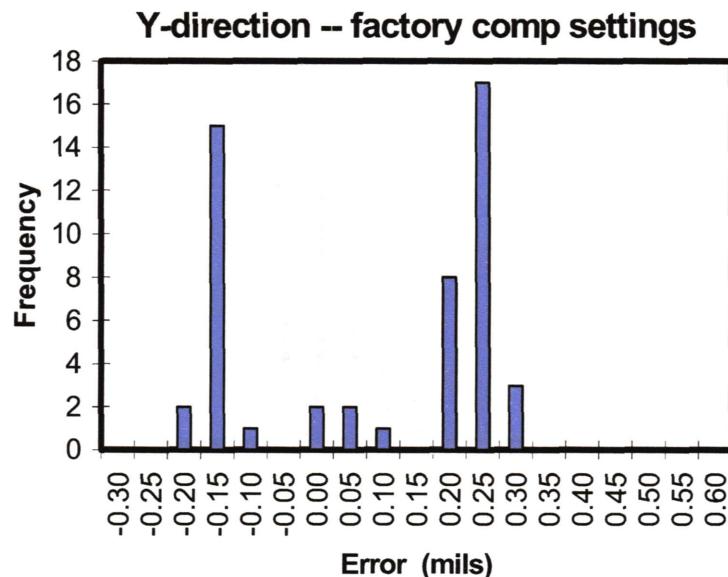
Fig. 5. Error in channel width in the Y-direction, deduced from the laser measurements in Fig. 4. Backlash comp. 28, friction comp. 80.

Comparing Figs. 5 and 7, it is clear that our adjustments to the backlash and friction compensation have greatly improved the Y-axis channel width error. In both X- and Y-directions, the widths of our 0.050" test channels are now within the $\pm 0.0002"$ spec.

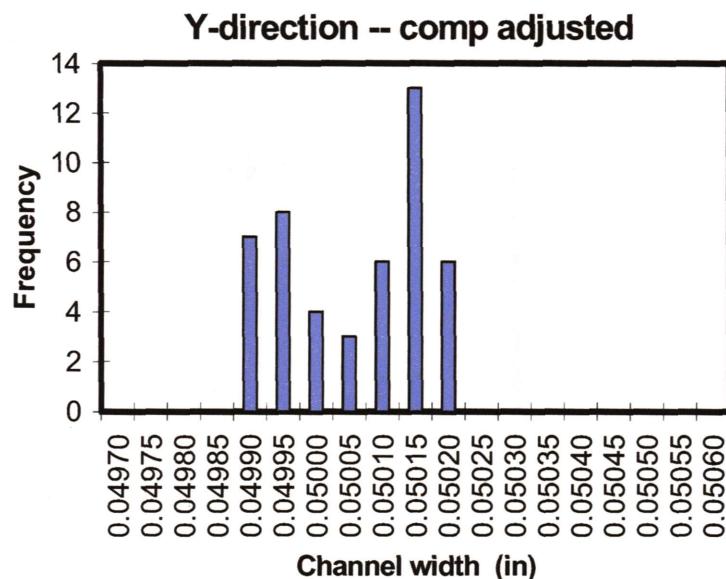
Fig. 6. Laser measurements of the channel width in the Y-direction. Backlash comp. 20, friction comp. 90.

On the informal advice of the Jeffreys/Haas technician, Pat, the Y-axis backlash and friction compensation parameters had been adjusted earlier in an attempt to improve the Y-channel-width error. In the absence of the laser interferometer at that time, the optimization was done using a dial gauge. The result for the subsequent laser test is shown in Figs. 6 and 7 with the backlash and friction compensation set to 20 and 90 resp.

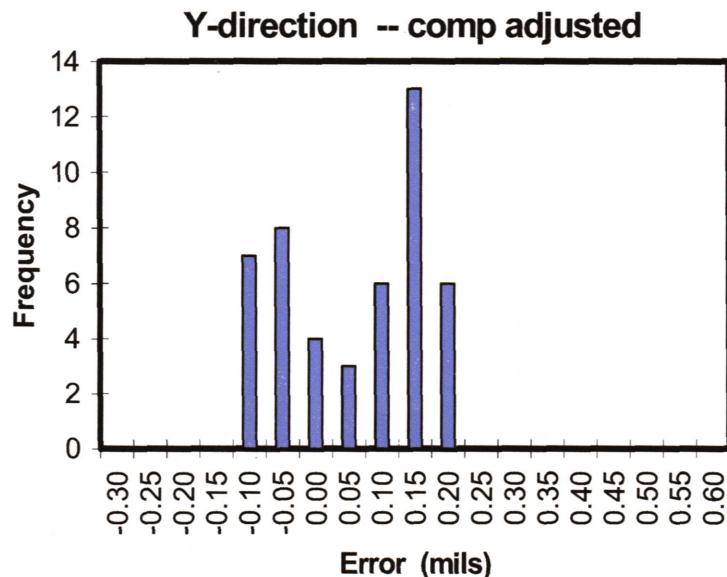
Fig. 7. Error in channel width in the Y-direction, deduced from the laser measurements in Fig. 6. Backlash comp. 20, friction comp. 90.

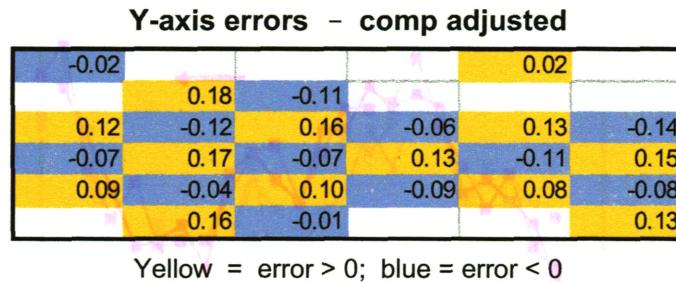
Fig. 8. Map of channel width errors in the Y-direction, deduced from the laser measurements. Backlash comp. 20, friction comp. 90.

The distribution of Y-axis channel width errors across the surface of the test area is mapped in Fig. 8. Positive errors are indicated by yellow, negative by blue.

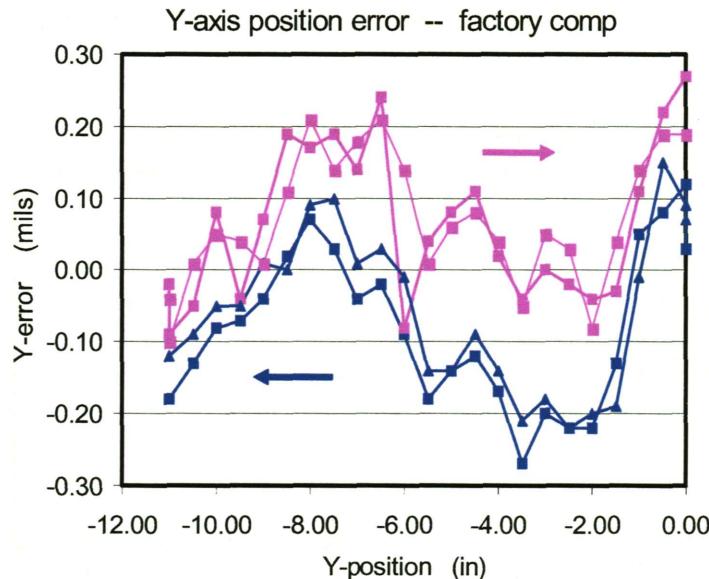
Fig. 9. Laser measurement of the Y-axis position error over two cycles. Factory compensation: backlash 28, friction 80.

To measure the long range accuracy and repeatability in the Y-direction, the table position relative to the spindle was measured over its range of motion. This was done with the factory compensation settings (backlash 28, friction 80) and with the improved settings (backlash 20, friction 90). The results are shown in Figs. 9 and 10.

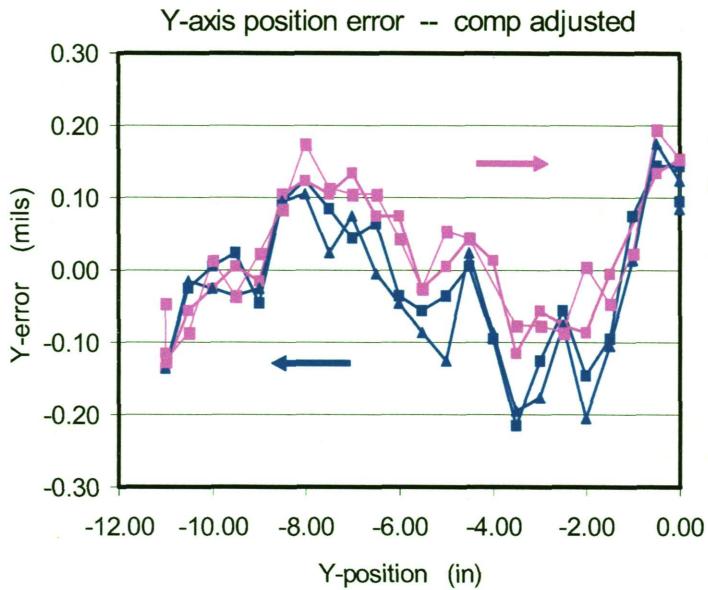
**Fig. 10. Laser measurement of the Y-axis position error over two cycles.
Adjusted compensation: backlash 20, friction 90.**

In the Y-direction, with the adjusted compensation settings, repeatability was never worse than $\pm 0.0001"$, regardless direction of approach – see Fig. 10. The Y-position error was within $\pm 0.0002"$ and had an almost sinusoidal variation over the 11" range of motion, as seen in Fig. 10. This would be easy to improve using the machine's internal correction table.

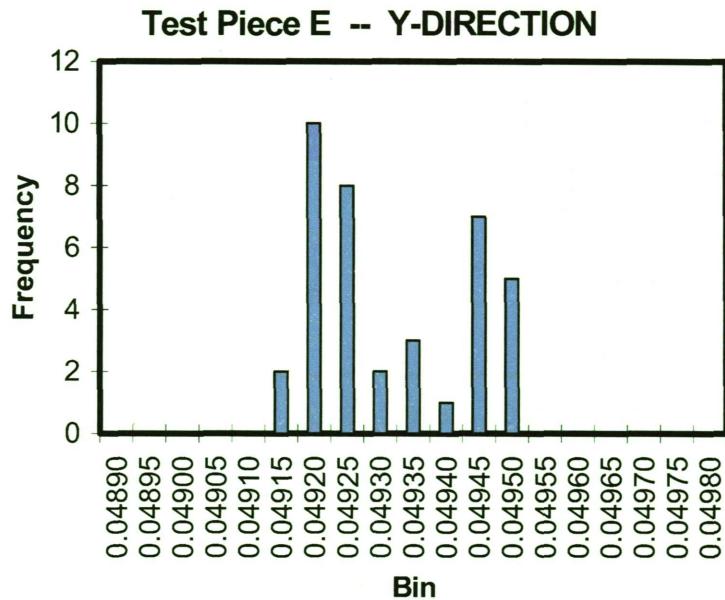
**Fig. 11. Microscope measurements of the channel widths in the Y-direction
for test piece E. Backlash comp. 20, friction comp. 90.**

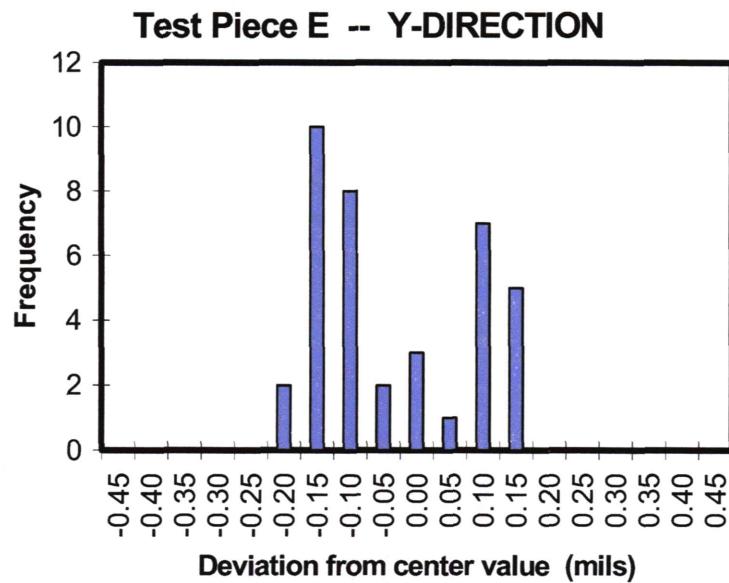
Fig. 12. Distribution of channel widths in the Y-direction, deduced from the above microscope measurements, for test piece E. Backlash comp. 20, friction comp. 90.

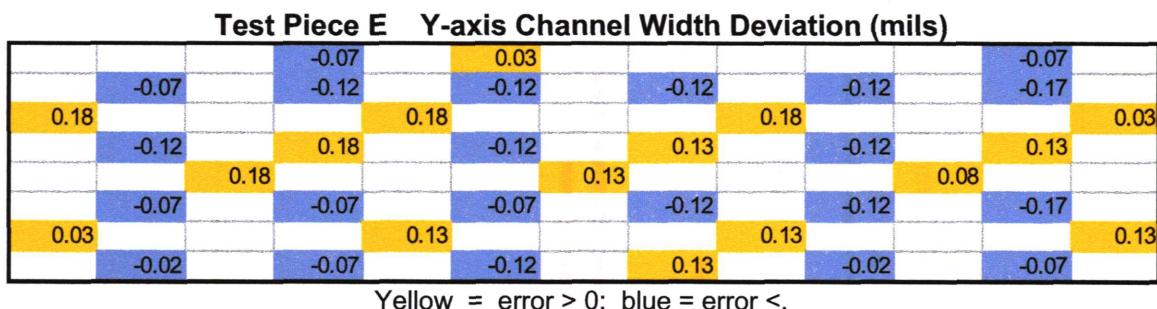
Fig. 13. Map of channel width errors in the Y-direction, measured by microscope on machined test piece E. Backlash comp. 20, friction comp. 90.

The distribution of Y-axis channel width errors across the surface of the test-piece is mapped in Fig. 13. Positive errors are indicated by yellow, negative by blue.

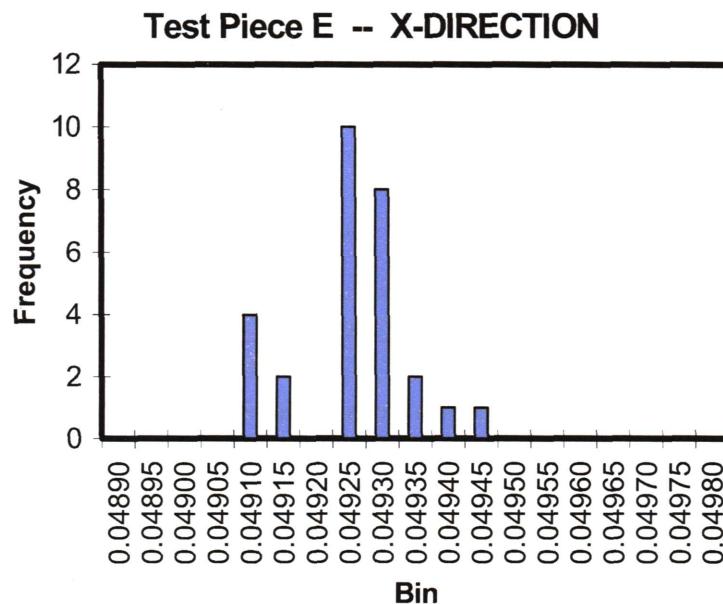
Fig. 14. Microscope measurements of the channel widths in the X-direction for test piece E. Backlash comp. 13, friction comp. 100.

The channel widths in the X-direction, measured by microscope, are shown in Figs. 14 and 15. X-axis backlash and friction compensation were left at the manufacturer's factory settings: backlash 13, friction 100.

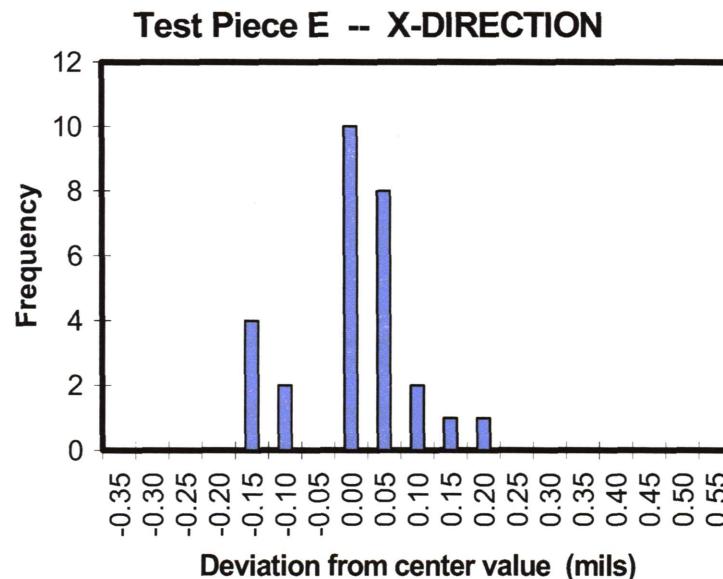
Fig. 15. Distribution of channel widths in the X-direction, deduced from the above microscope measurements, for test piece E. Backlash comp. 13, friction comp. 100.

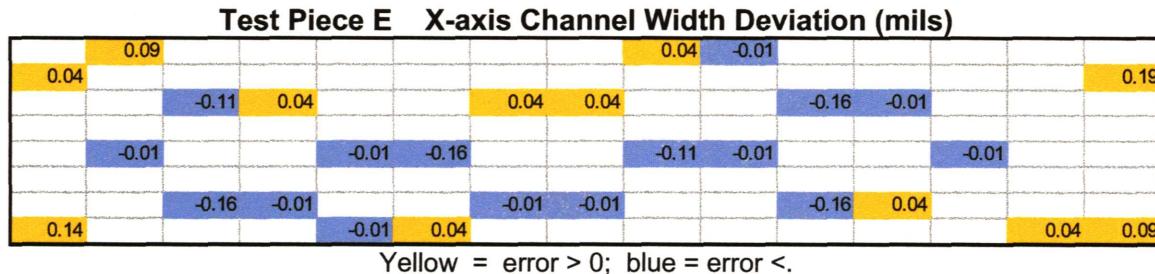
Fig. 16. Map of channel width errors in the X-direction, measured by microscope on machined test piece E. Backlash comp. 13, friction comp. 100.

The distribution of X-axis channel width errors across the surface of the test-piece is mapped in Fig. 16. Positive errors are indicated by yellow, negative by blue.
