VLA ELECTRONICS MEMO NO. 239

Bracket for Waveguide Extension at B rack

Steve Grayson

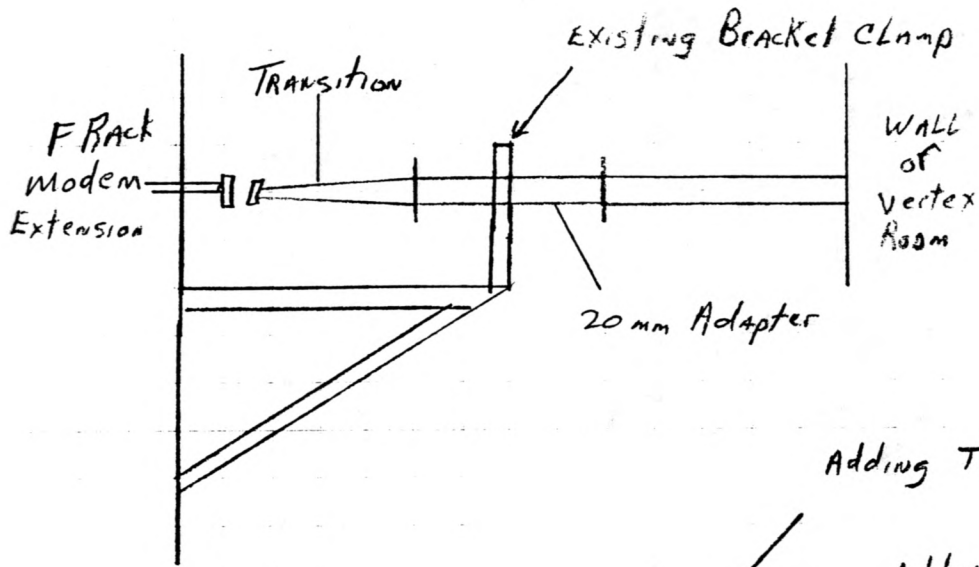
Adding Two Turnbuckles

By adding an additional clamp to the waveguide protruding from the vertex wall and attaching turnbuckles between the two clamps we can eliminate the stress on the six inch piece of waveguide.

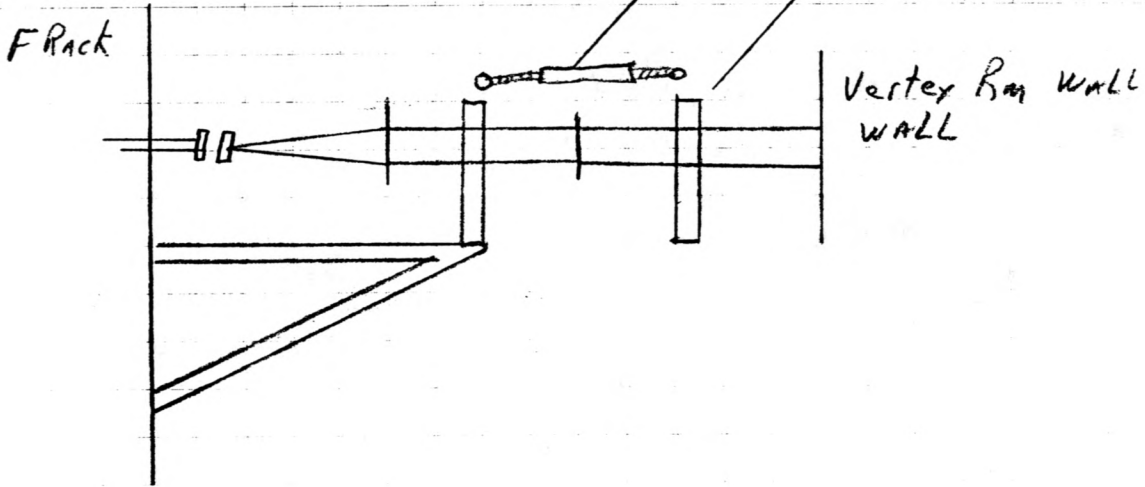
Adding new Bracket clamp
