Digital Spectrometer Autocorrelator 1- 18 GHz Down Converter, EMS Automation, Rohn Tower Repair, and TV Action Updates

Nathan Thomas
NMIMT Electrical Engineering Undergraduate
Socorro, New Mexico
January 3rd through July 31st, 2001

National Radio Astronomy Observatory
VLA/VLBA Electronics Division
Interference Protection Group

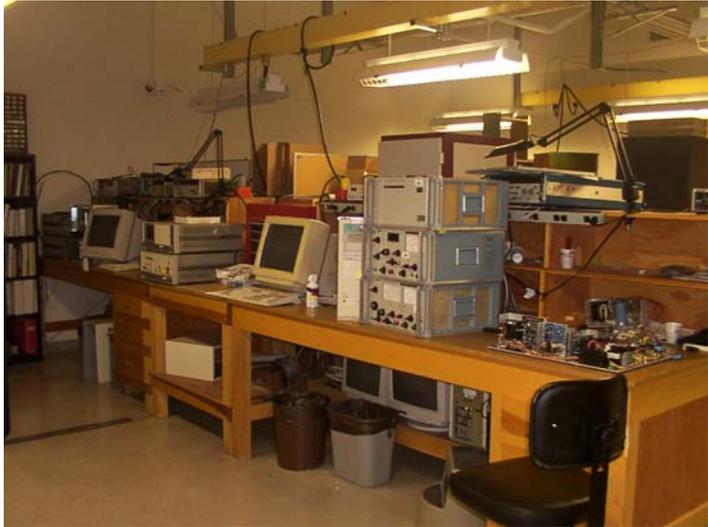
IPG Lab benches. EMS system on the right most bench during testing.

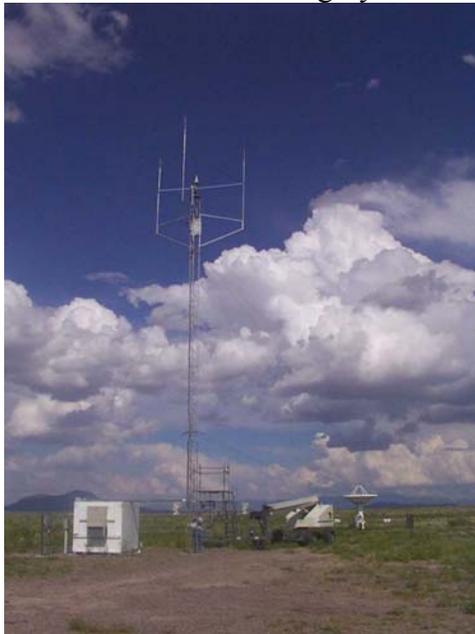
The EMS Tower next to the RFI Shelter

The EMS system uses the antennas that are located on the RFI tower. The Rohn tower is triangularly shaped with the sides about eighteen inches wide. The tower folds at nineteen feet above the ground. This made for really easy access to the antennas and Front End on the tower. The towers total length is almost 55 feet.
