NATIONAL RADIO ASTRONOMY OBSERVATORY

VLBA Antenna Memo 97  
VLBA Pie Town Wheel Replacement (8/2016)

Work Dates: 8/29-8/30

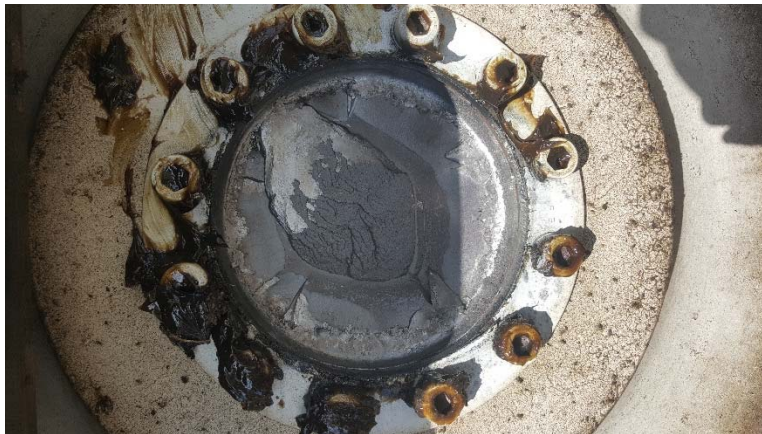
Drive wheel #1 had an axel failure and was temporarily fixed by installing the Saint Croix wheel assembly.

While removing the wheel, the outer pillow block separated from the wheel assembly, exposing the broken axel. Figure 1 details the wheel and broken axel.

The SC wheel assembly had the axel cut at the VLA prior to arriving at Pie Town. After the new wheel was placed, we noticed the axel was cut at an angle. This angle did not allow the dial indicator to be placed in the traditional location. We were able to modify the measuring technique and move the dial indicator to the front of the gear coupling. Once this was figured out, the remaining wheel alignment and adjustments went smooth. There were no real problems or red flags with the installation. We slewed the antenna for approx. 20 minutes before handing it off to operations for pointing tests.
