NATIONAL RADIO ASTRONOMY OBSERVATORY
Green Bank, West Virginia
Electronics Division Internal Report No. 122

TEST OF SOME MM-WAVE MATERIALS

Lars Pettersson*

AUGUST 1972

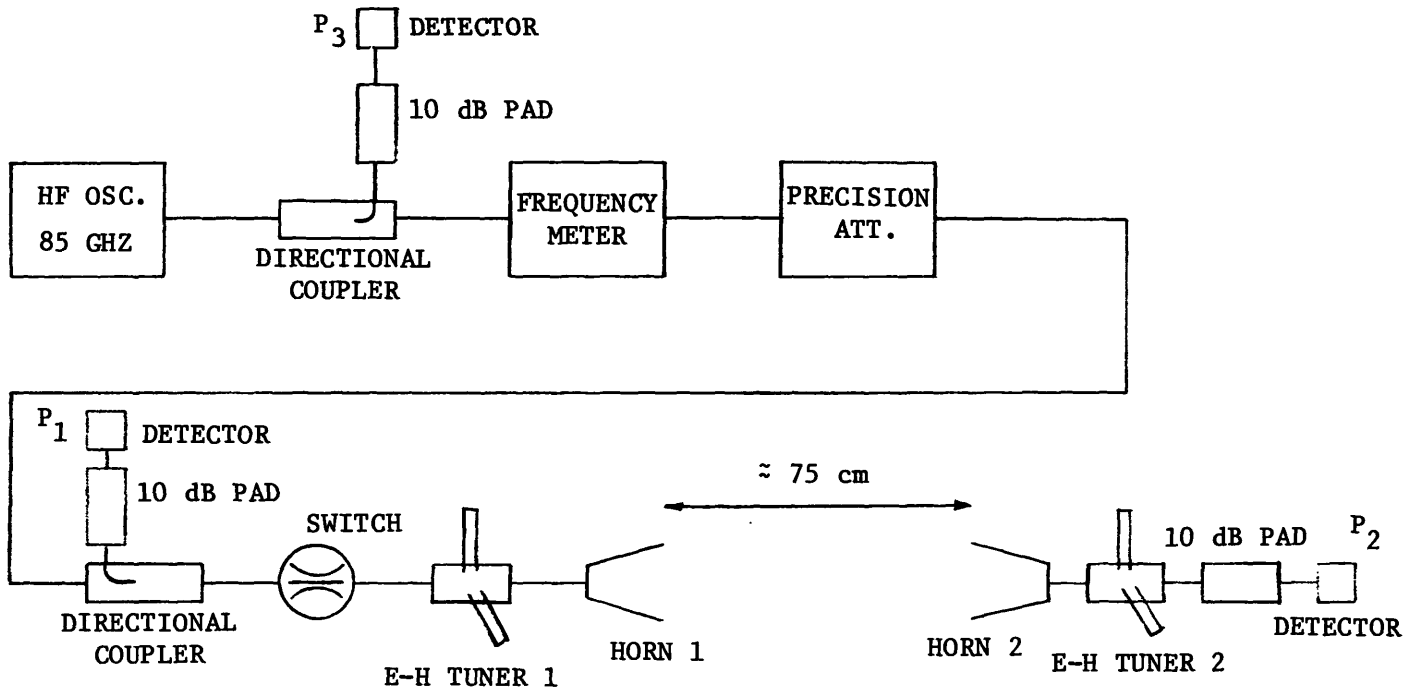
Figure 1

When the system (Fig. I) had been matched with E-H tuner 1, $P_1=0$ with the switch to space, a piece of the material was held in front of horn 1 oriented for maximal reflection. The switch was then tuned to total reflection and the attenuator set for the same P_1 . The reflection is given by difference in attenuator readings

A.1. Reflection - material between horns

Here the system first was tuned without horn 2 (tuner 1), and then with horn 2 (tuner 2). The material was then held between the two horns at an angle of about 20° so that the reflected power would not enter horn 1. This would increase the measured reflected transmission loss. Then the ratio $\frac{P_3}{P_2}$ was measured with a logarithmic amplifier and digital voltmeter. Because of the small difference between P_2 and P_3 and variations (random) in the system this measurement was difficult to do so, a mean-value was taken over a number of readings.

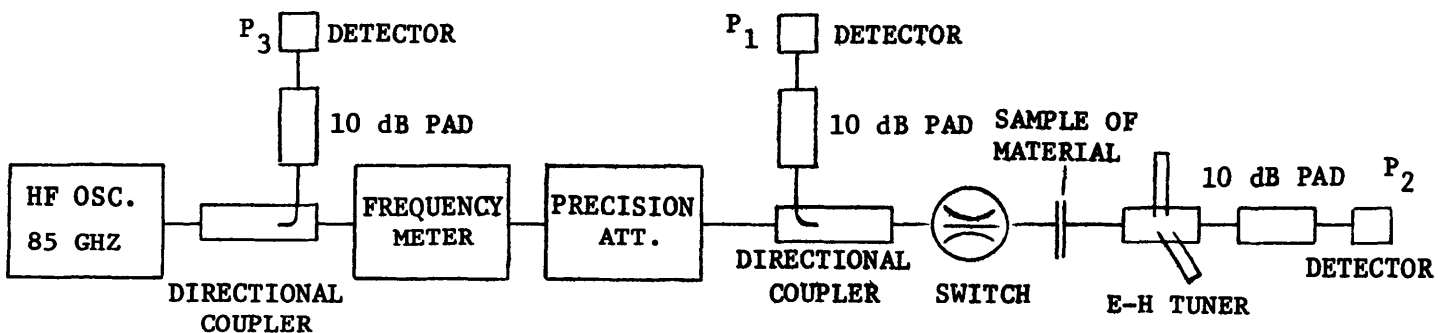
Figure 3

The measurement was done with system, Fig. III, as described in section 2.B.1, but here the measurement was even more sensitive than in 2.A.2 to the waveguide junction.

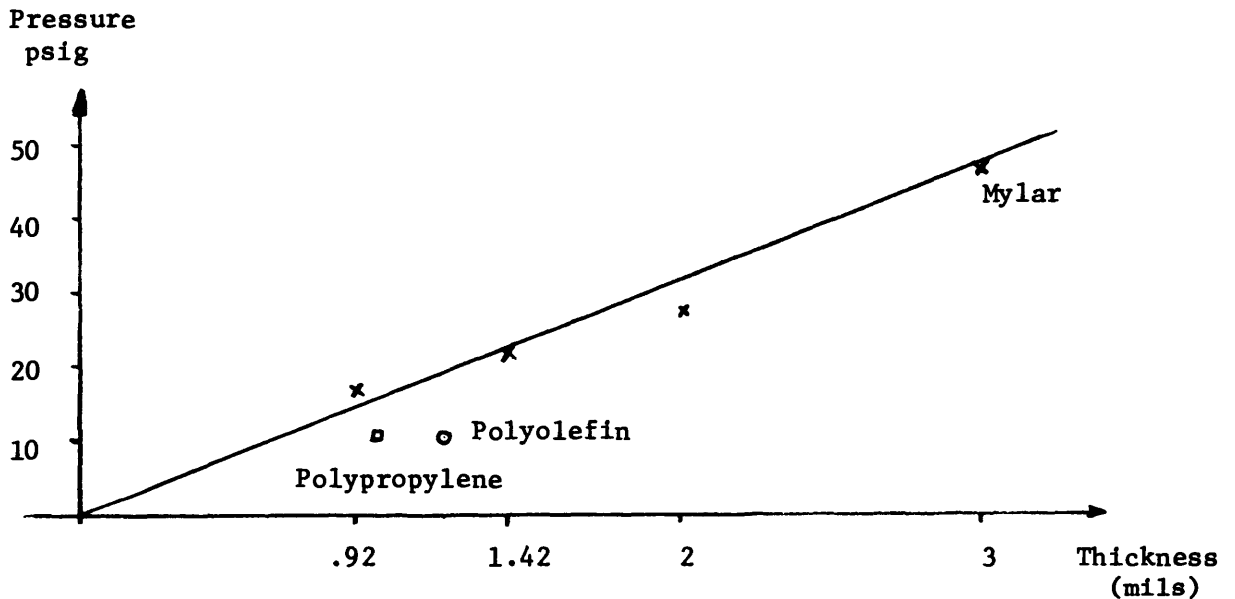
Graph 1

Material		Thickness	Bursting Pressure psig	Elongation above plane of ring [mm]
Mylar A	92	.00092"	17	44
"	142	.00142"	22	46
"	200	.002"	28	48
"	300	.003"	47	48
Polyolefen	220PP-2D	.0012"	11	41
Polypropylene		.001	11	30

A sample of the material was securely clamped between two rings with inside diameter of 10 cm. The edges of the rings were rounded, and an indium gasket was used to insure even clamping pressure. The assembly was then mounted on a pressure vessel, and bursting pressure and deformation measured.

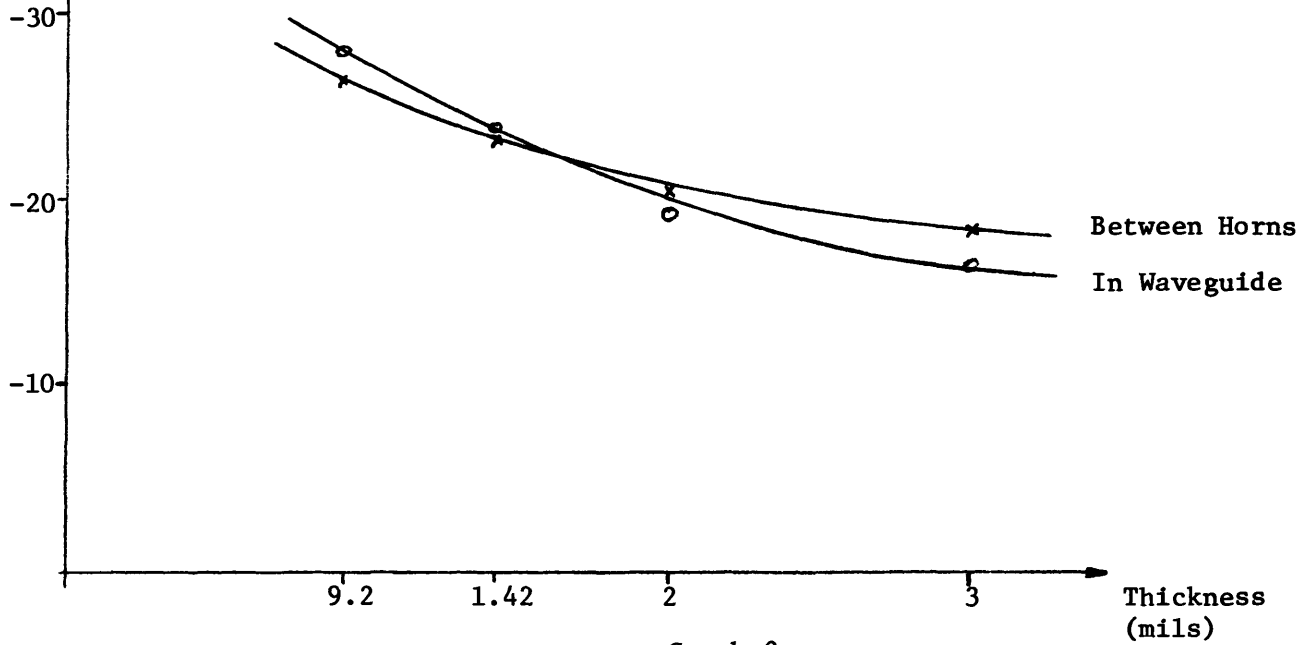
Graph 2

Reflection
dB

REFLECTION AS A FUNCTION OF THICKNESS FOR MYLAR

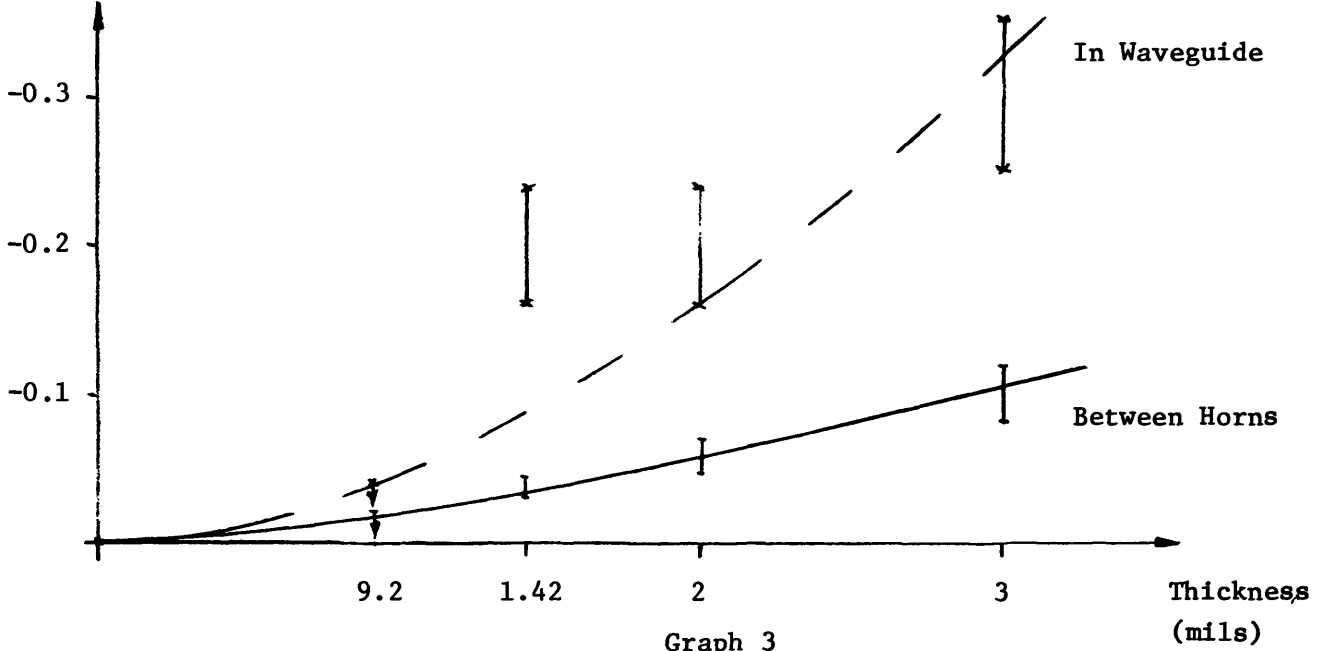
Graph 3

Transmission
dB

TRANSMISSION AS A FUNCTION OF THICKNESS FOR MYLAR

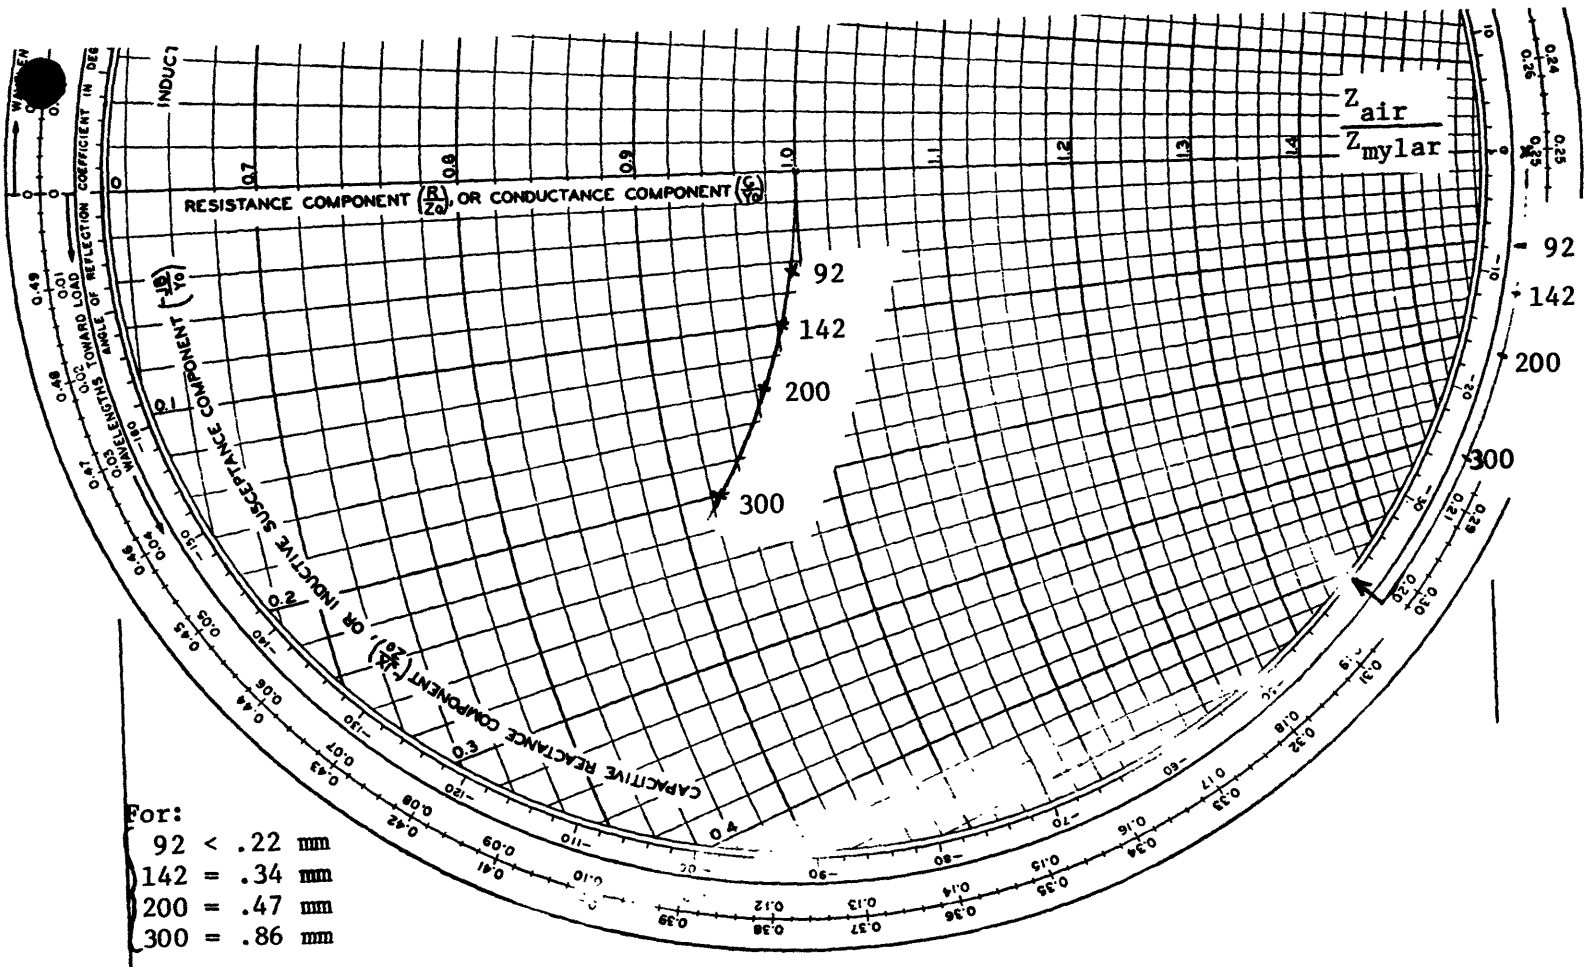
Figure 4

We can also get some theoretical values using a Smith chart, see Fig. IV.

Using $E_r = 2.7$ for mylar and assuming loss factor $\tan \delta = 0$ gives

Reflection Loss (dB)
Mylar	92	29.2
"	142	25.6
"	200	22.5
"	300	19.0
