NATIONAL RADIO ASTRONOMY OBSERVATORY
Green Bank, West Virginia

MEMORANDUM

Subj: RFI Tests on PowerTec Brushless Motor and Controller

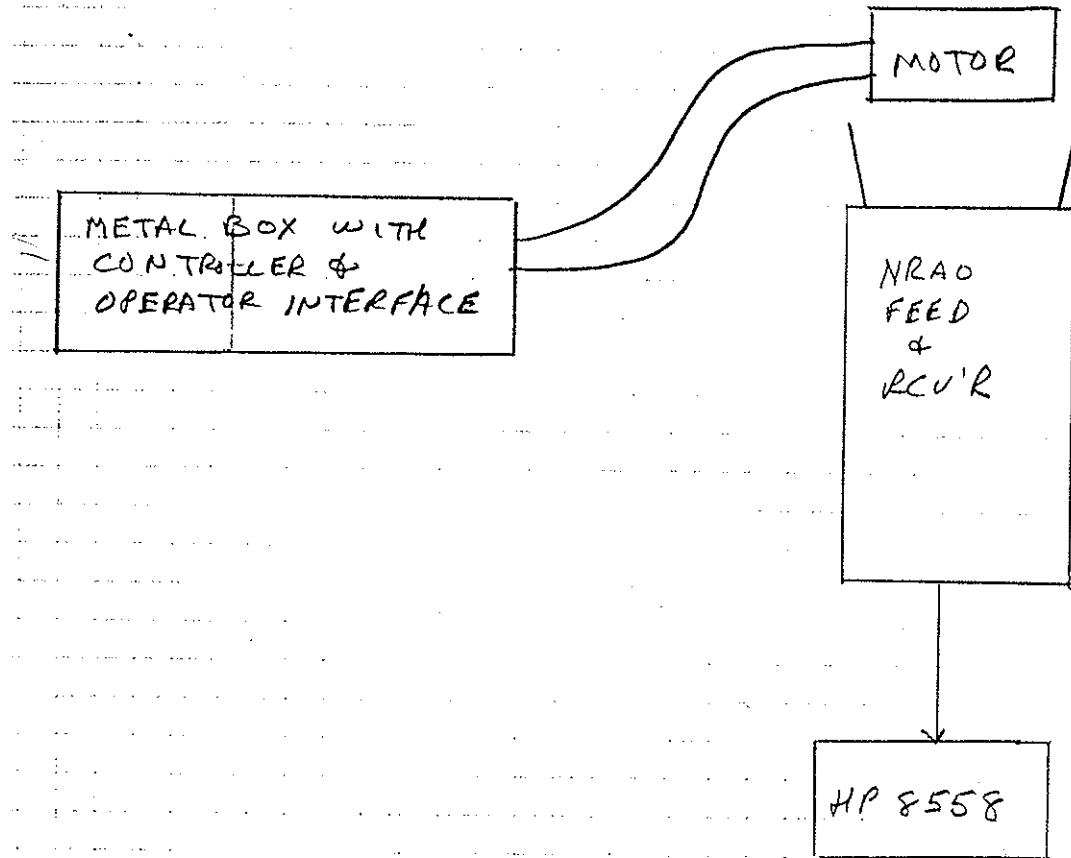
BRUSHLESS MOTOR OUTDOOR TEST SET-UP

350-450 MHz

OR

1300-1500 MHz

FEED POINTED AT ZENITH FOR MOST TESTS. ALSO
POINTED AT HORIZON FOR ONE CONTROLLER TEST.

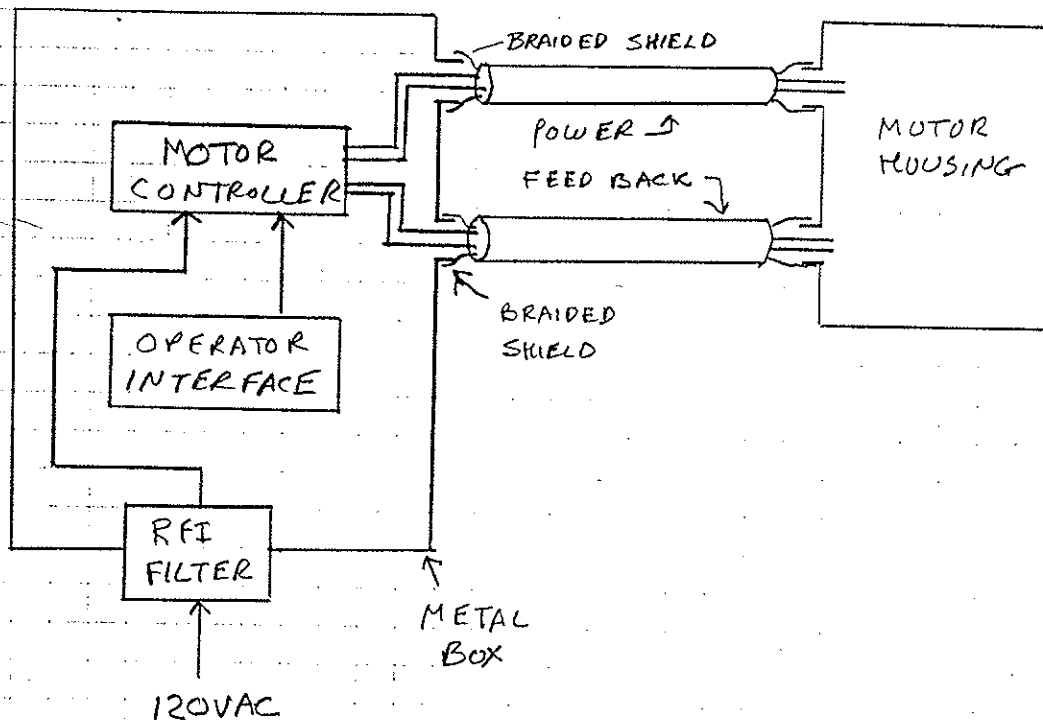
BRUSHLESS MOTOR RFI INDOOR TEST SET-UP

CONTROLLER: POWERTEC, MODEL 500
MOTOR : POWERTEC, 1HP BRUSHLESS
MODEL 214ASA1000700000

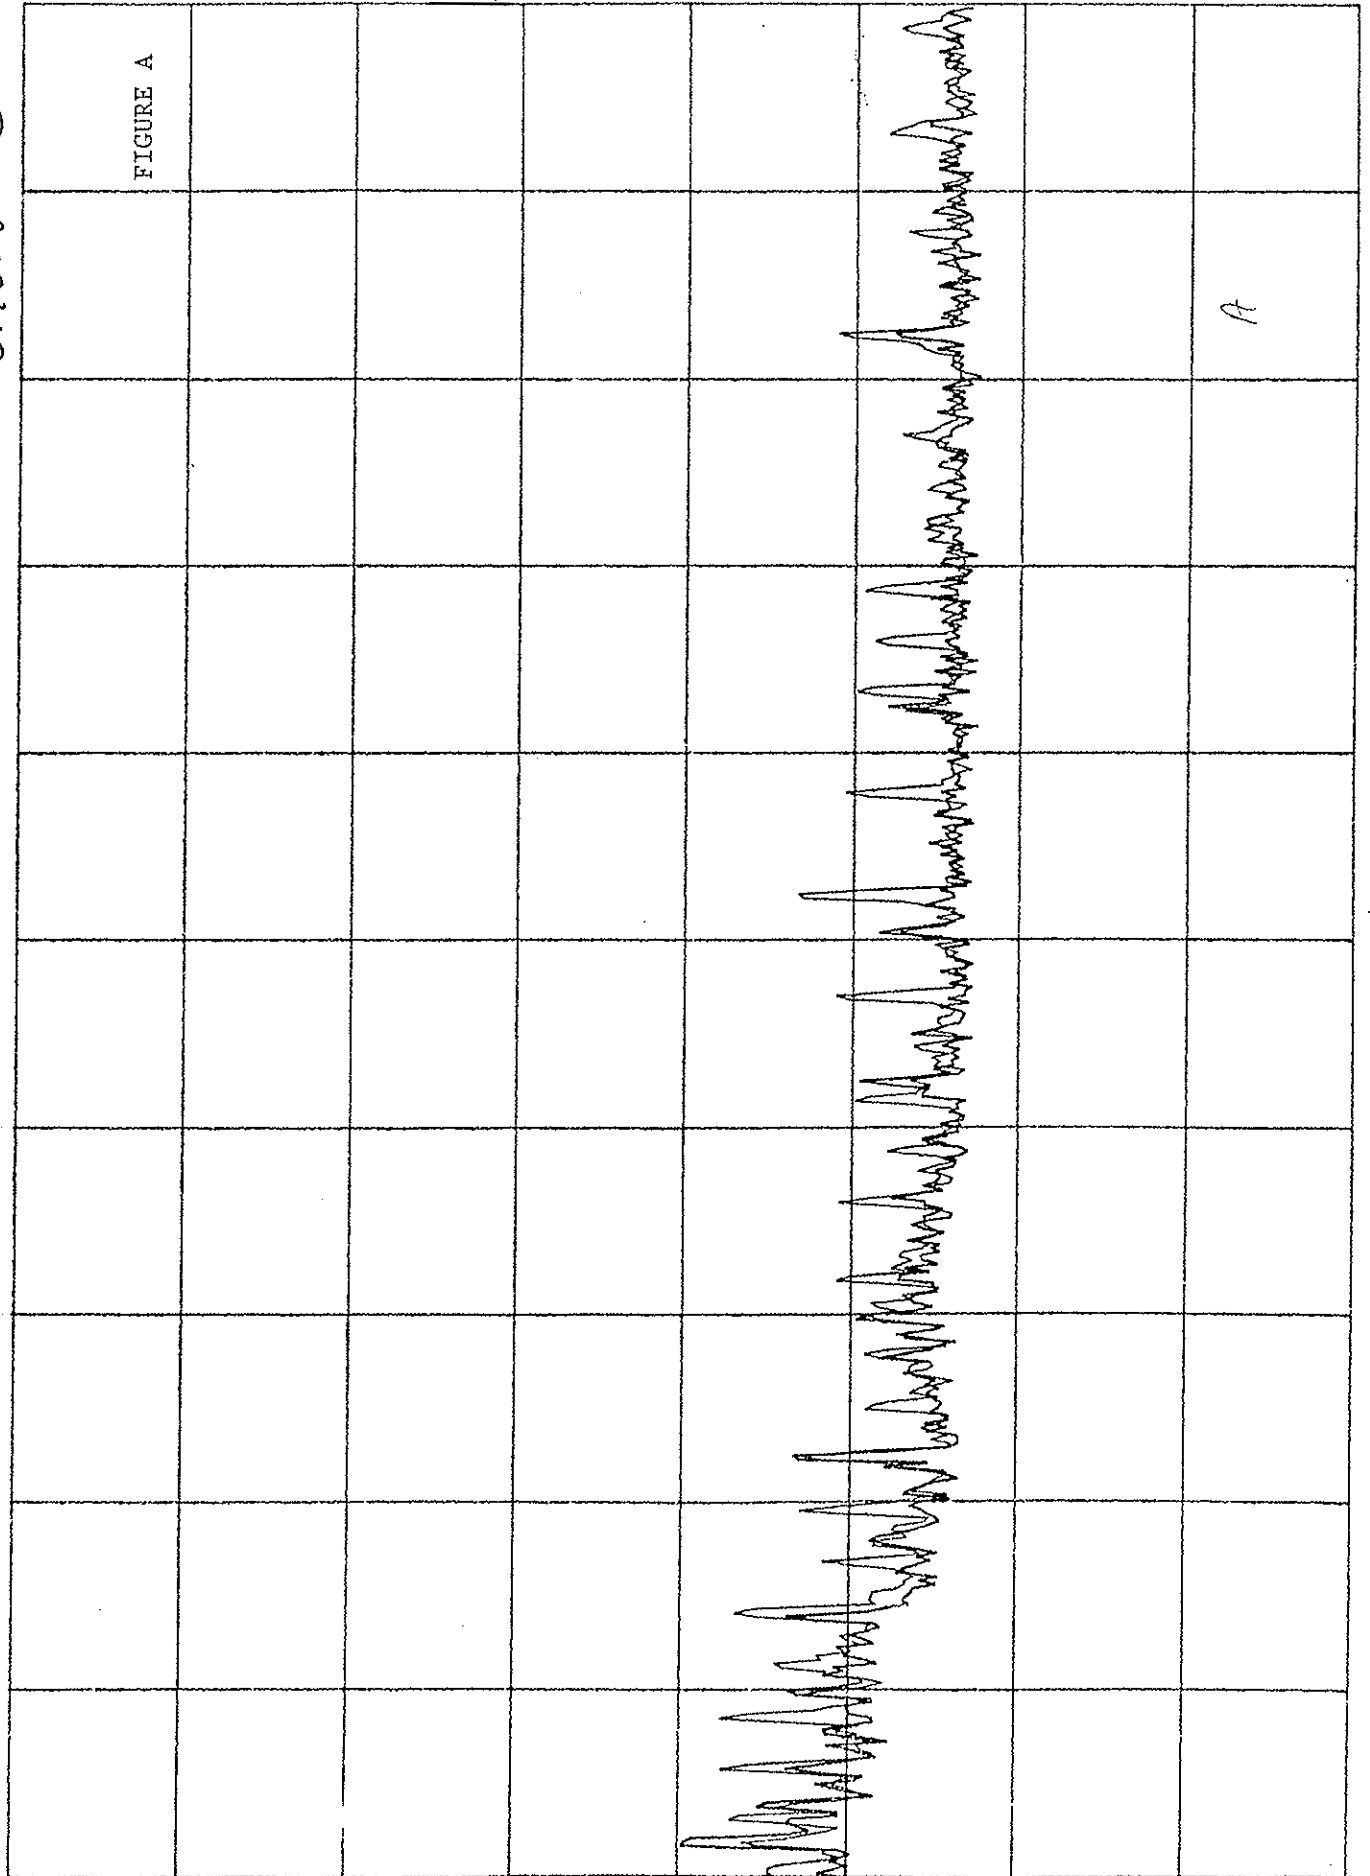
FIGURE B

MOTOR CONTROLLER ON/OFF 4/30/92

MAX HOLD

IN BOX COVER OFF

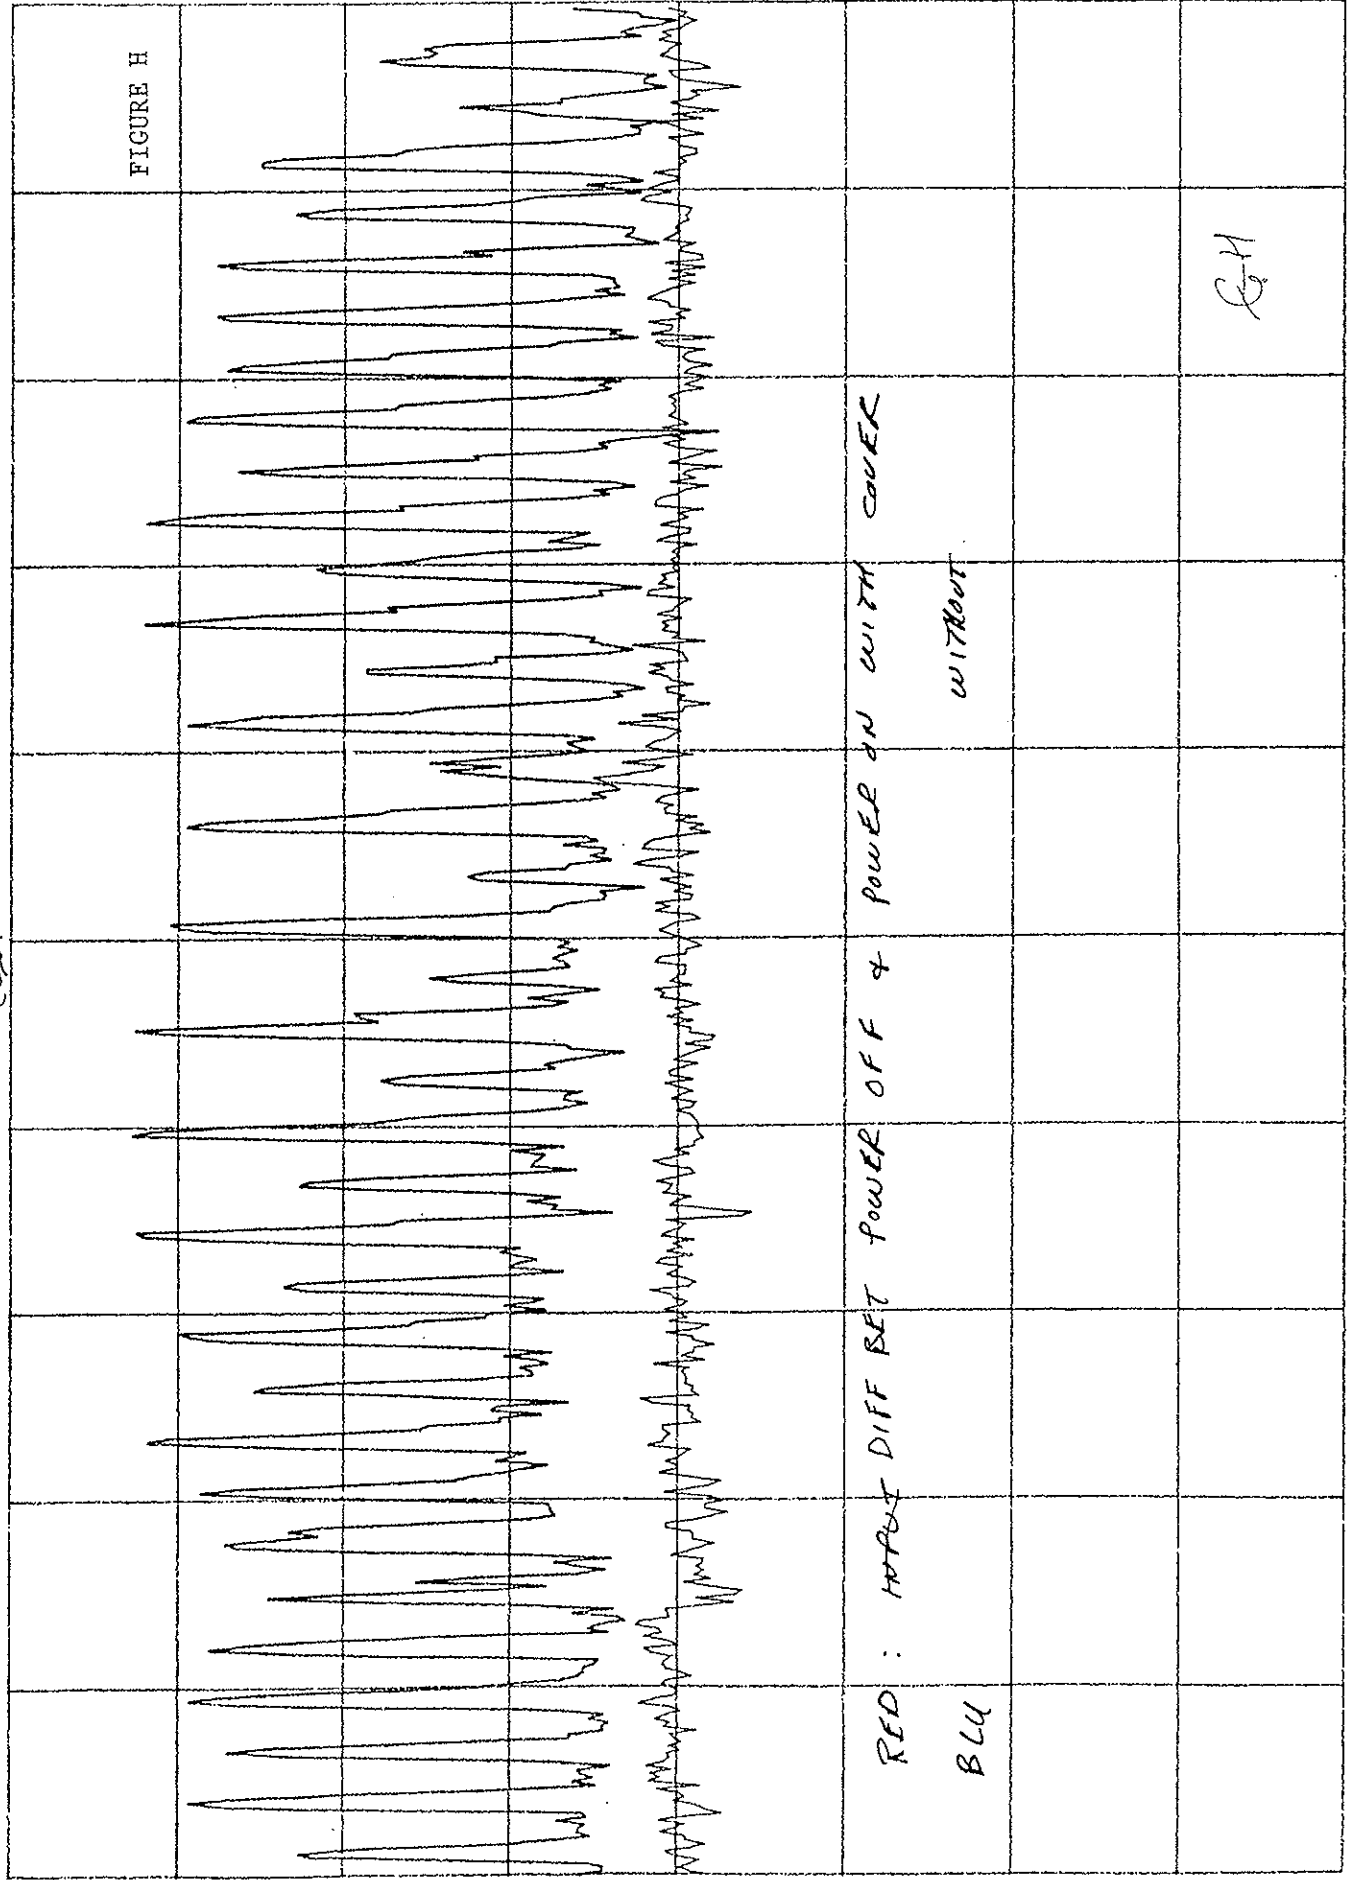
PLOT # 10

RED : INPUT DIFF BET POWER OFF & POWER ON WITH COVER
 BLUE : WITHOUT

8 APR 92 MOTOR CONTROLLER IN FRONT OF 21CM RX FEED

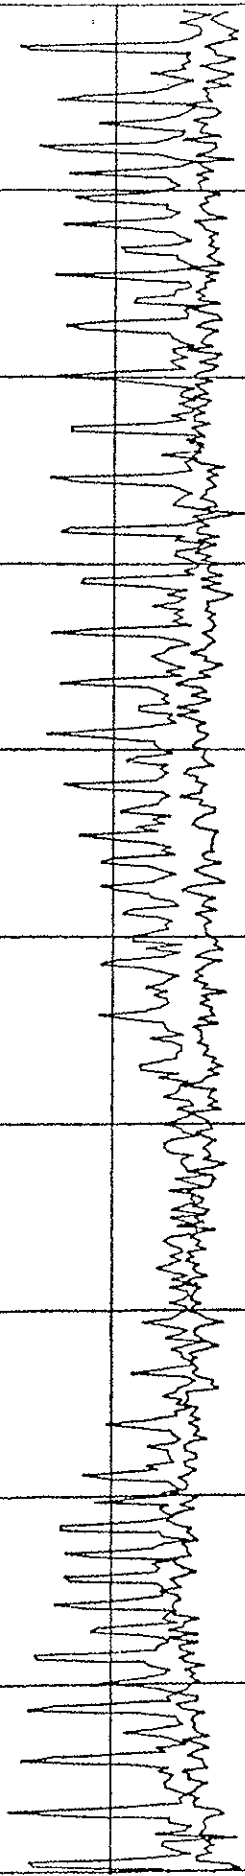
FIGURE J

PLOT # 11

8 APR 92 MOTOR IN FRONT OF 21CM RX FEED

POWER ON/OFF

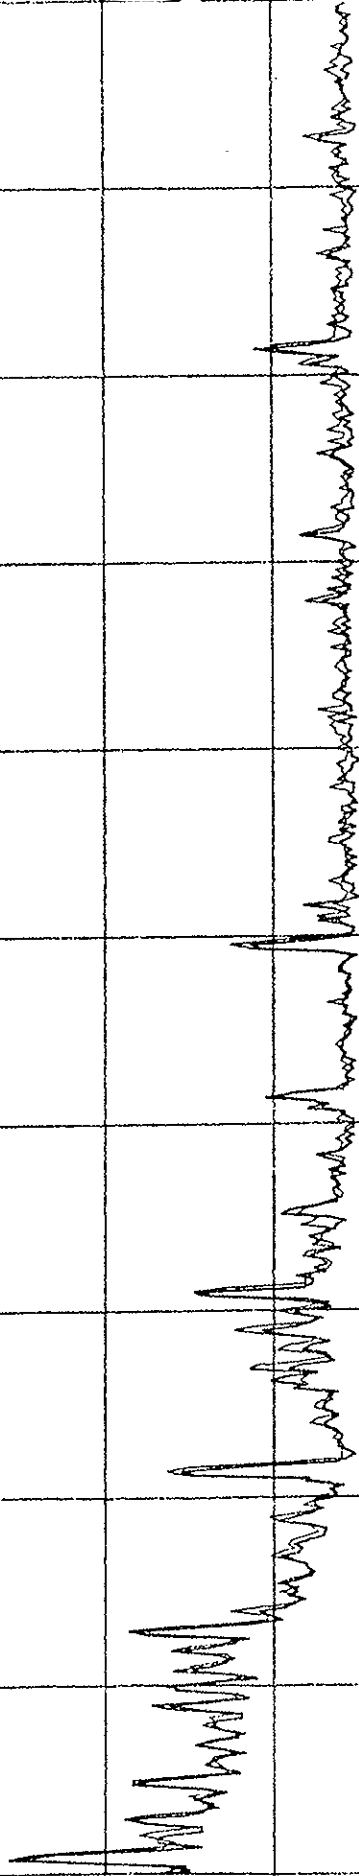
FIGURE N

COVER ON 276 CO

ON/OFF POWER
