National Radio Astronomy Observatory VLBA Antenna Memo Series – No. 87

TRIP REPORT - Kitt Peak Azimuth Drive Wheel Assembly #2 Replacement
9-11 Feb 2012

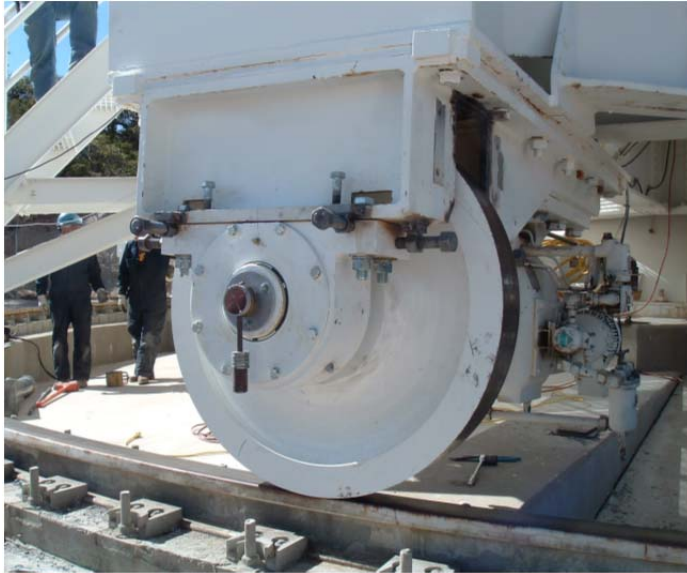
Illustration 1: Wheel During Final Alignment

The old wheel assembly was removed and the new assembly was installed without incident. Wheel alignment was performed and the final measurements were within the specified tolerances as shown in the table below.

<u>Specifications with Tolerances</u>	<u>Measured Values</u>
Conic Radius:	300.00" \pm .25"	300.086"
Drive Coupling TIR:	< .005"	< .003"
Axle Vertical Slope:	93.440° \pm 0.023°	93.442°
Axle Horizontal Angular Error:	< .023°	.013°
